Brightwood Park Ecological Mapping Report – September 2020

Prepared for Tim Van Epp, Town of Westfield Green Team
Prepared by Michael Van Clef, Program Director, New Jersey Invasive Species Strike Team

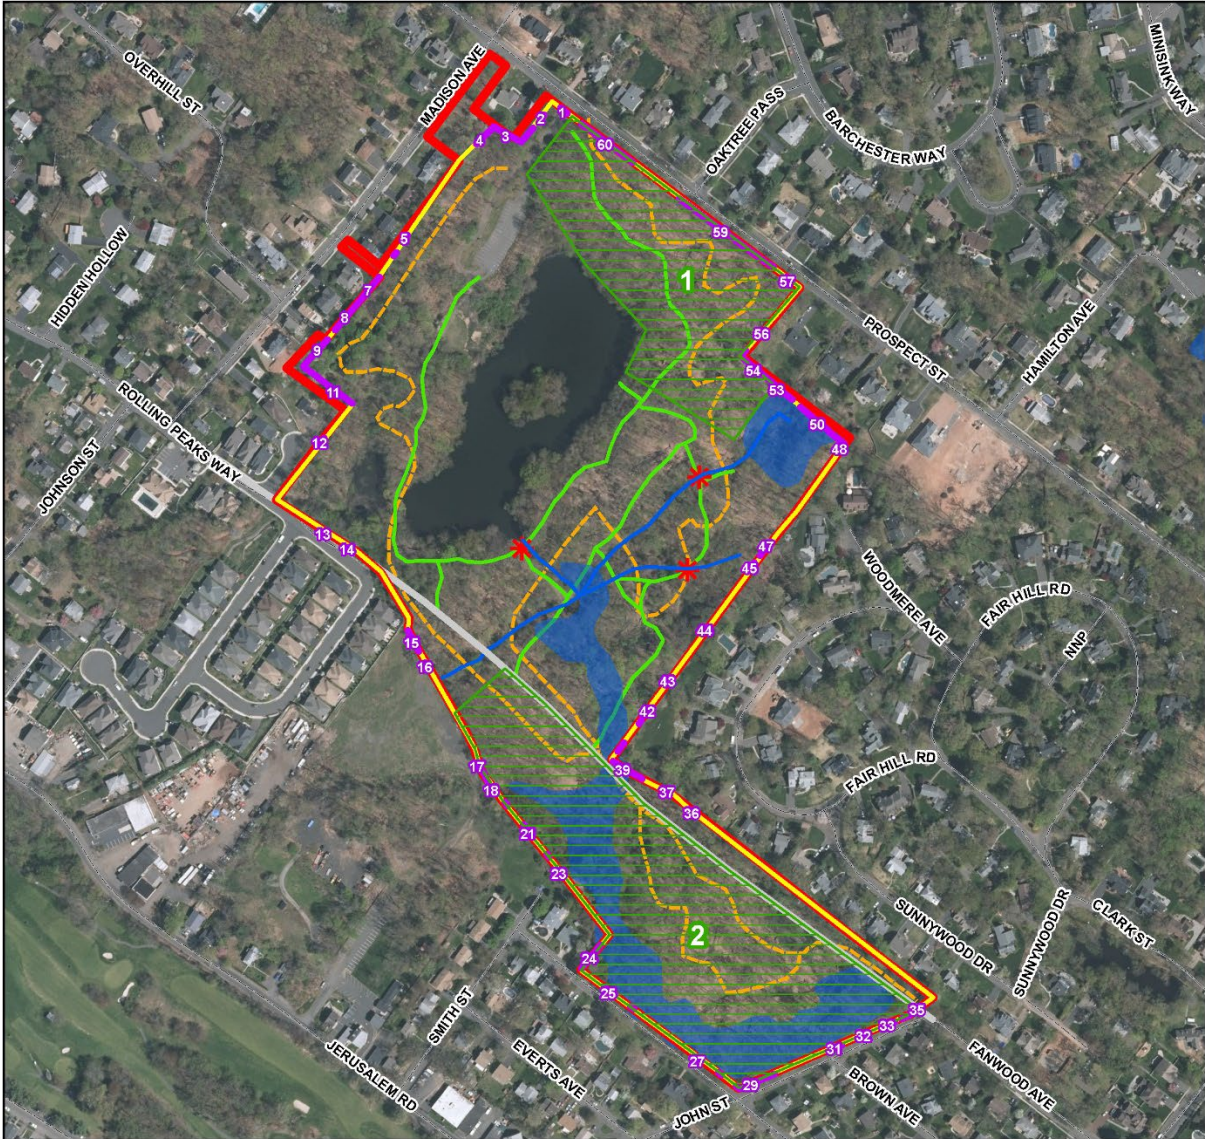
Map 1. Brightwood Park Ecological Mapping Evaluation - Entire Park

The entire fence perimeter is approximately 7,310 feet. A summary of fence condition by damage type is provided in Table 1 with details of 60 mapped locations provided in Table 2. Approximately 27% (1,975 feet) of the fence requires removal of dense vegetation (6%), extension of fence bottom

to reach ground level (10%) or significant repair / replacement (11%). Approximately 3% of the fence perimeter includes sections replaced by neighbors and/or replaced by the Township in the recent past.

The entire fence perimeter is 6 feet in height. It is recommended that two additional wire strands be placed at 1-foot intervals to increase the effective height to 8 feet.

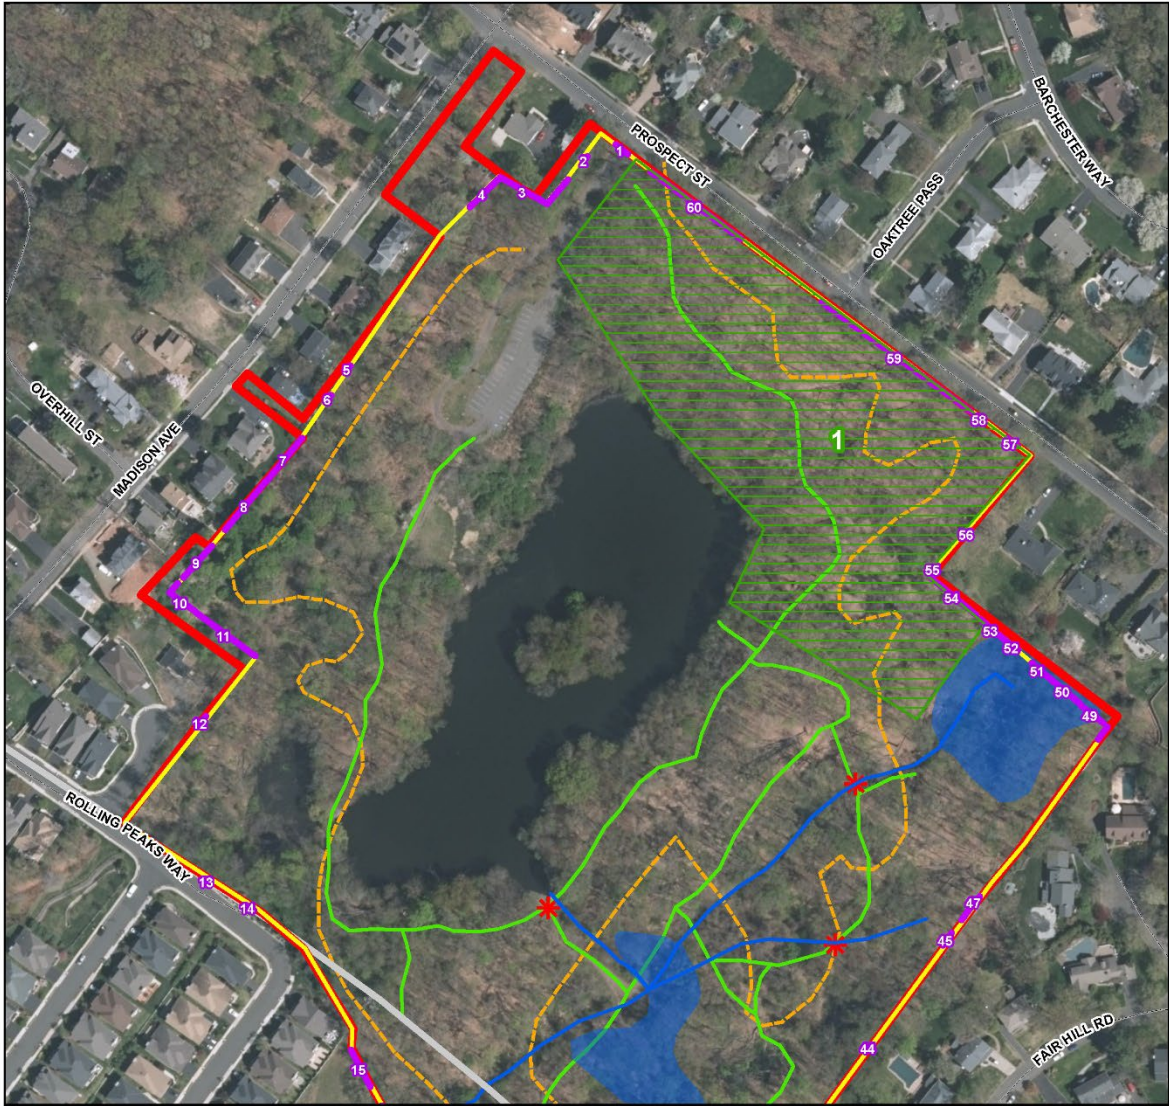
Map 1A. Brightwood Park Ecological Mapping Evaluation – Northern Portion of Park

- Area #1 is 5.5 acres with a perimeter of 2,350 feet (includes 1,050 feet of existing Park perimeter fence)
- Area #1 boundary was drawn to minimize interference with existing trails, but two self-closing pedestrian gates are required on the existing gravel trail.
- Non-infested or lightly infested areas cover 75% of Area #1.
- Heavily infested areas (especially Chinese Wisteria but also Japanese Knotweed, Multiflora Rose and others) are included in Area #1 so that post-treatment recovery is hastened by the lack of deer browse.
- There are no NJDEP GIS wetlands in Area #1.
- Area #1 features mature trees including Red Oak, White Oak, Black Oak, Sweet Birch, American Beech, Mockernut Hickory, Flowering Dogwood, Maple-leaved Viburnum, Lowbush Blueberry, Black Huckleberry, Sarsaparilla and Pennsylvania Sedge. The entire area has sparse native wildflowers due to excessive deer browse.

- Contains approximately 4.0 acres of native plant community virtually free of invasive species. The understory and ground layers have been largely removed through years of excessive deer browse.
- Contains approximately 1.5 acres of heavily infested area. Control is feasible but could require up to 150 hours of effort including well-trained volunteers or contractors specializing in invasive species control. Following initial treatment, follow up spot treatments would be required annually. The initial treatment, if conducted solely by a contractor, has an estimated cost of \$5,500.
- Species include Chinese Wisteria (extensive but currently being treated), Japanese Knotweed, Multiflora Rose, Garlic Mustard, Mugwort, Northern Catalpa, Black Locust, Japanese Stiltgrass and English Ivy.

- For Area #1, repairs to existing perimeter fence primarily involve extending existing fencing to ground level and are likely to be relatively inexpensive (See Table 2, damage area numbers 54-60). New fencing would be required along 1,300 feet for an approximate cost of \$9,100. One existing trail occurs in this area, additional biking trails have been proposed but are not recommended for this area.

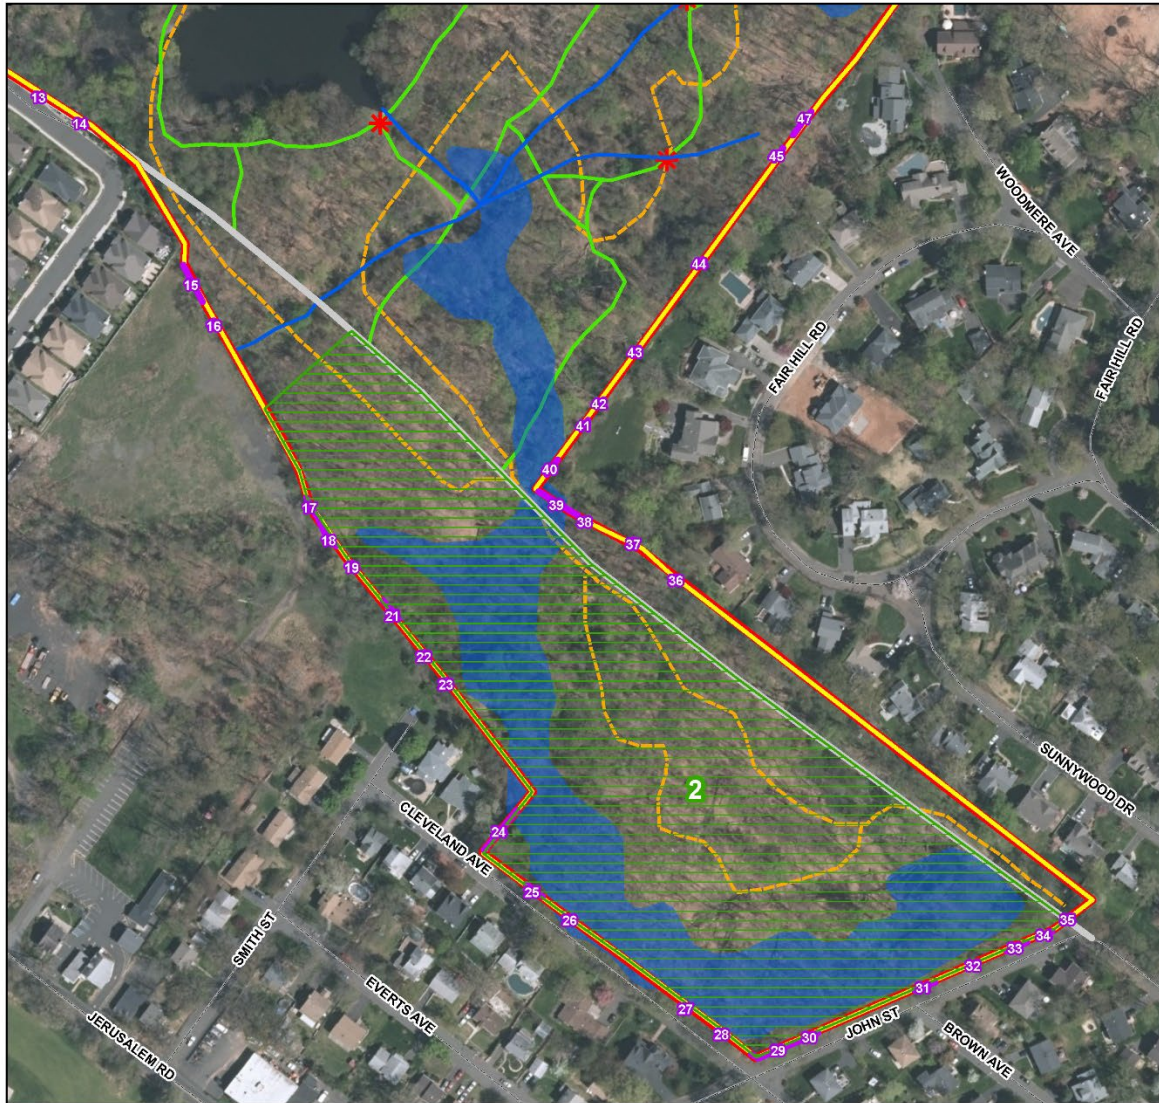
Map 1B. Brightwood Park Ecological Mapping Evaluation – Southern Portion of Park

- Area #2 is 9.5 acres with a perimeter of 3,290 feet (includes 1,780 feet of existing Park perimeter fence).
- There are no trails within Area #2, but two self-closing pedestrian gates off of the existing unimproved road are recommended for stewardship access (at eastern and western ends of area).

- Non-infested or lightly infested areas cover 75% of Area #2 (two distinct 'clean areas' occur on the western and southeastern portions of Area #2).
- Heavily infested areas (located in between the cleaner portions of the area) are included in Area #2 so that post-treatment recovery is hastened by the lack of deer browse.

- Contains approximately 7.0 acres of native plant community virtually free of invasive species. This area contains at least one dozen exceptionally large old trees. The understory and ground layers have been largely removed through years of excessive deer browse.

- The adjacent unimproved access road is heavily infested on both sides of the road and is therefore a high priority for treatment to protect Area #2. In addition to species listed above, this area also includes Japanese Barberry and Chinese Wisteria. This area is an additional 2.5 acres and would require significant heavy clearing utilizing a forestry mower followed by hand spraying of resprouts. Costs of forestry mowing varies but may be up to \$5,000 to clear the entire 2.5 acres. Hand treatments following forestry mowing, if solely conducted by a contractor, has an estimated cost of \$2,500.

- For Area #2, damage to the existing perimeter fence is more extensive and would incur additional costs to exclude deer (See Table 2, damage area numbers 17-34). New fencing would be required along 1,510 feet for an approximate cost of \$10,600. This area does not have any existing trails and it is recommended that the proposed biking trail not be built in this area.
