Pequest Wildlife Management Area / Kenco Acquisition

Kenco Wetland Restoration Project

Overview

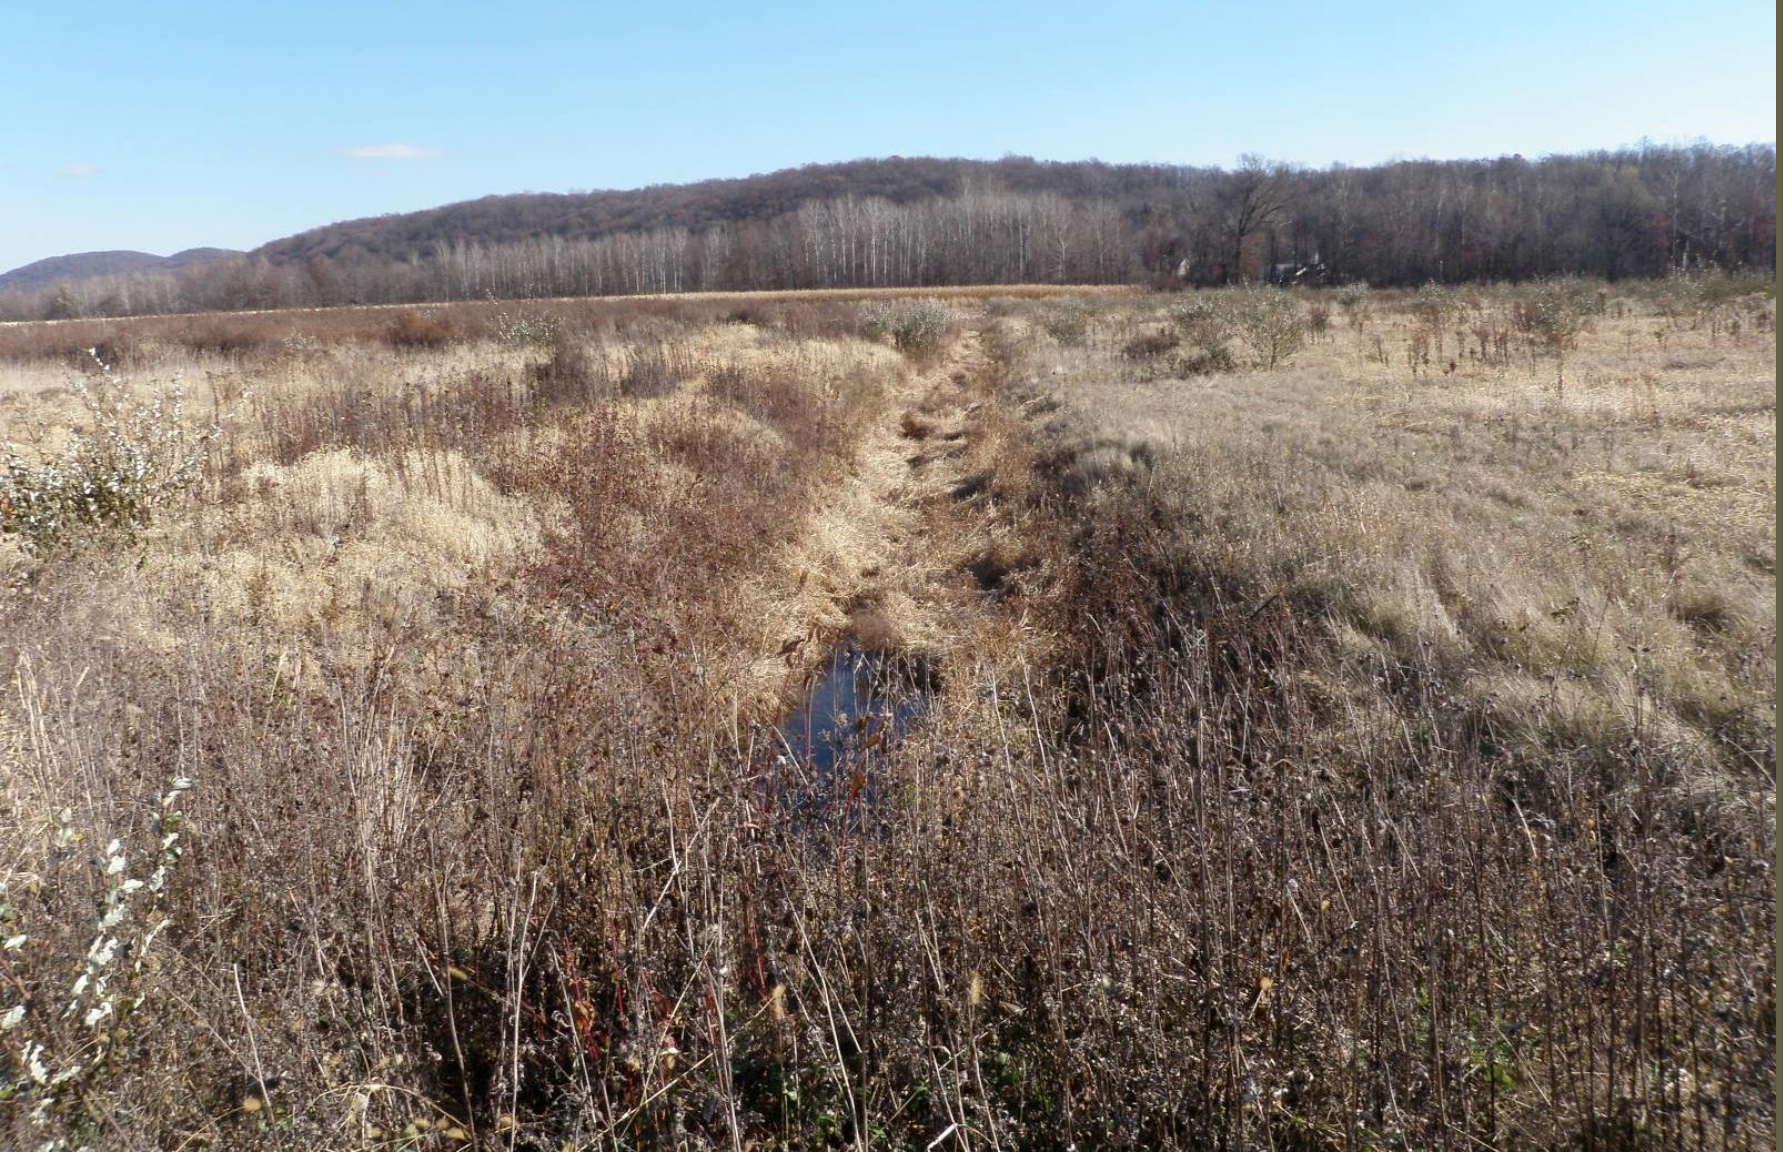
Site: before

Ditch draining the site

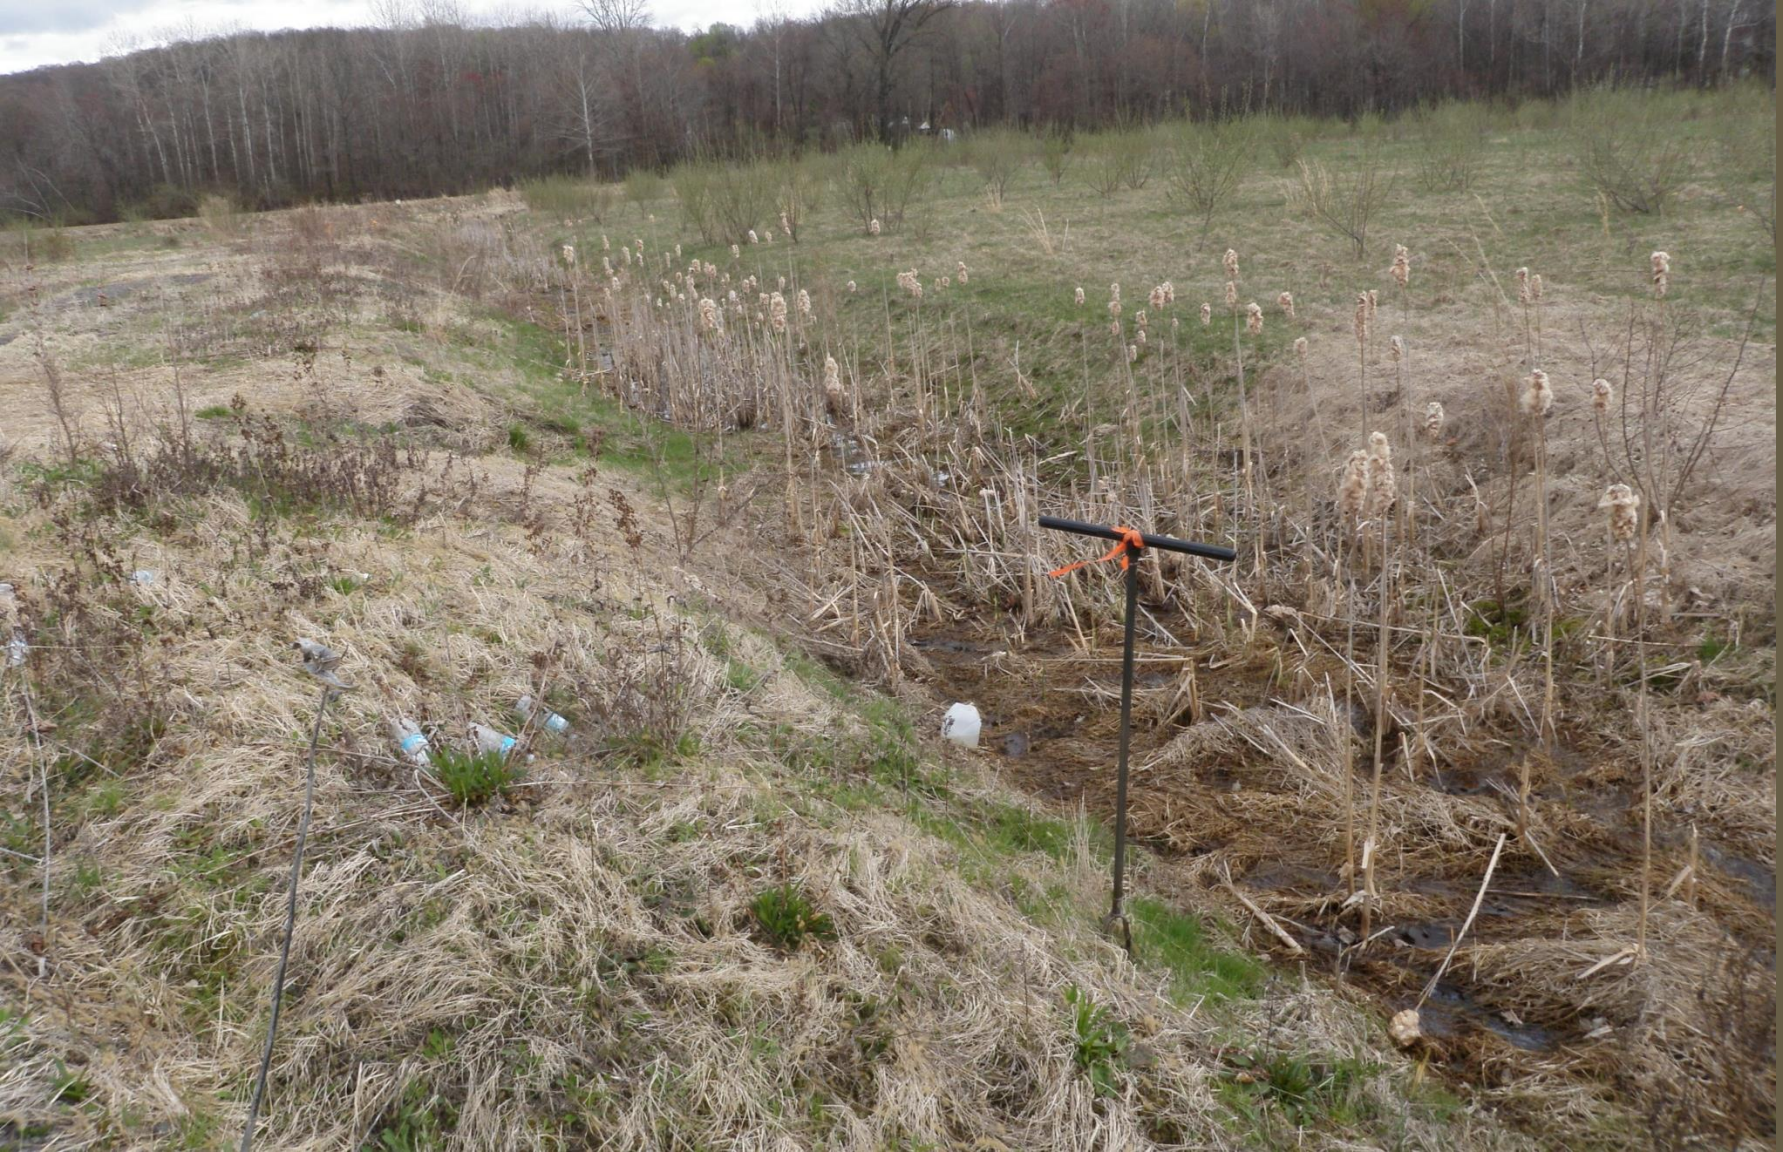
Site: before

Ditch draining the site (central portion): pre-grading
Note cattails, trash, and Autumn Olive

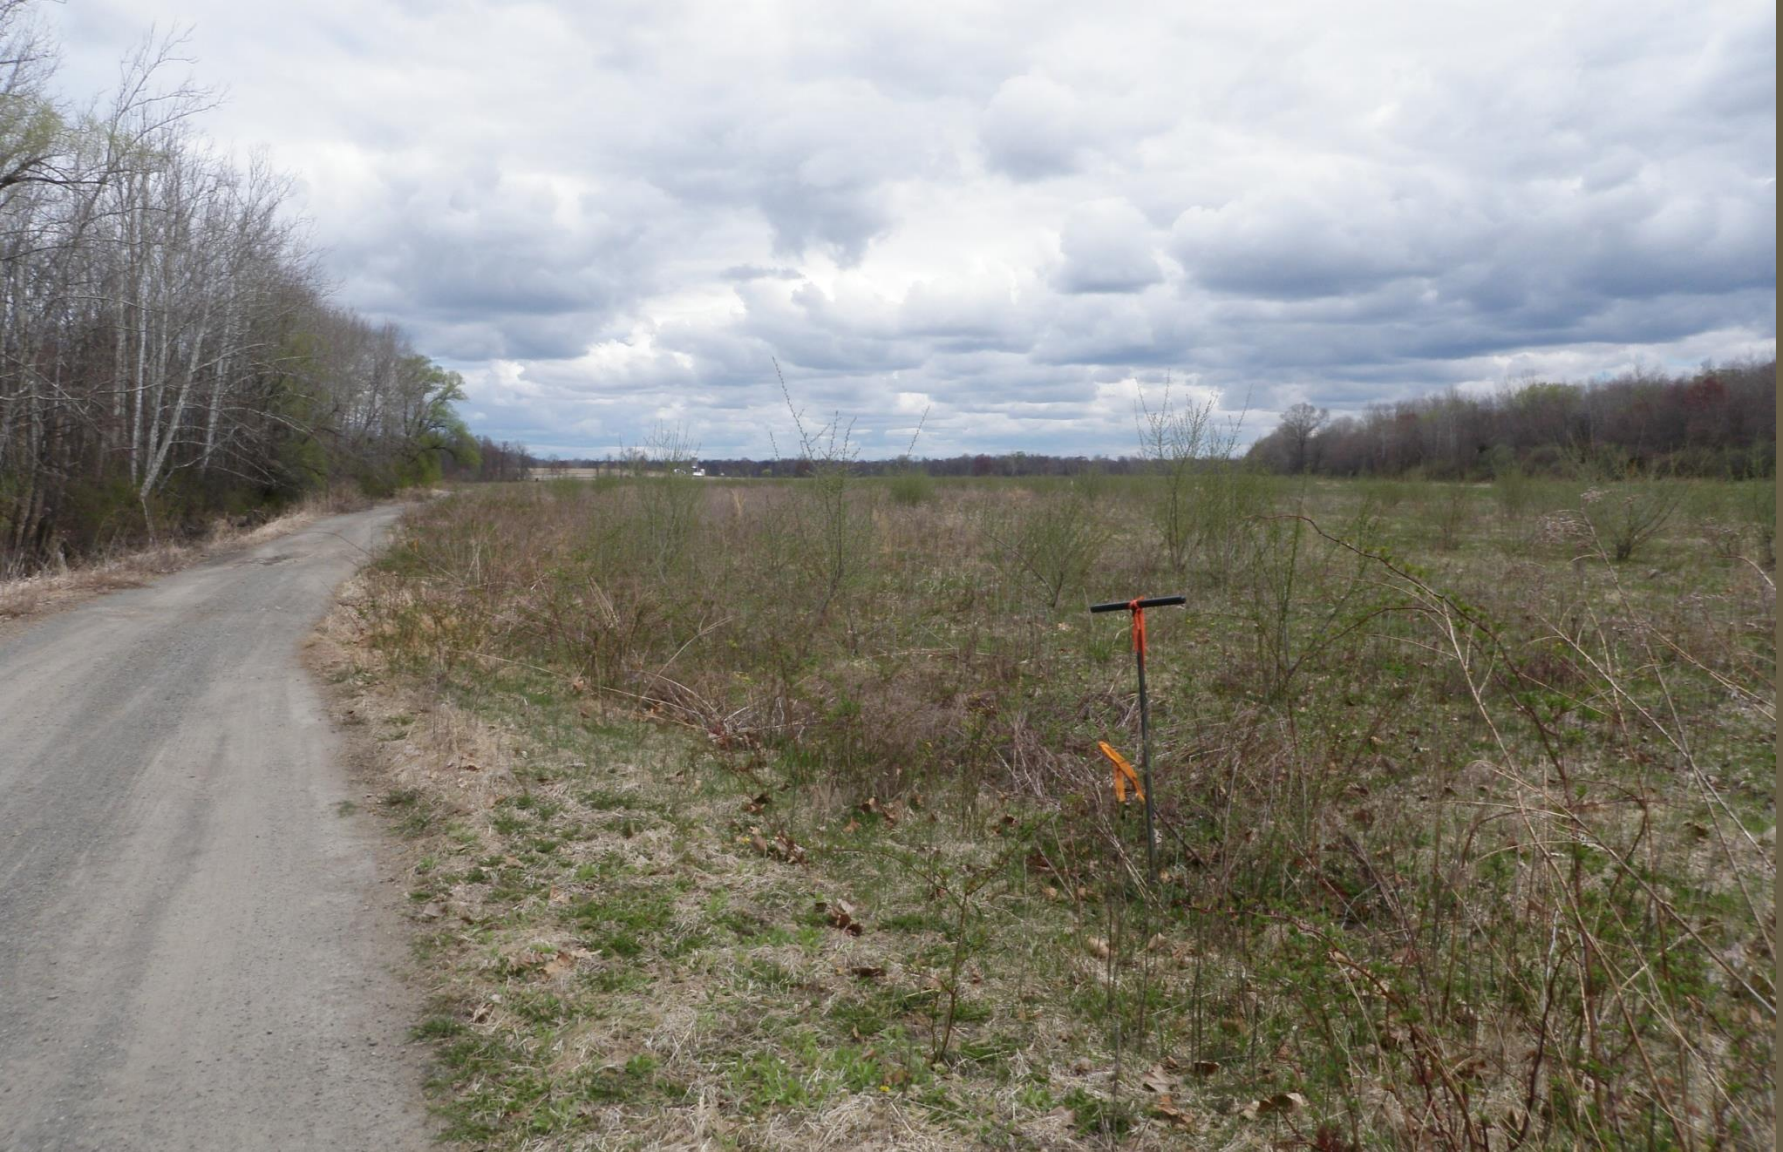
Pequest Riparian Shelf: before

Access road, taken during wetland delineation, pre-grading

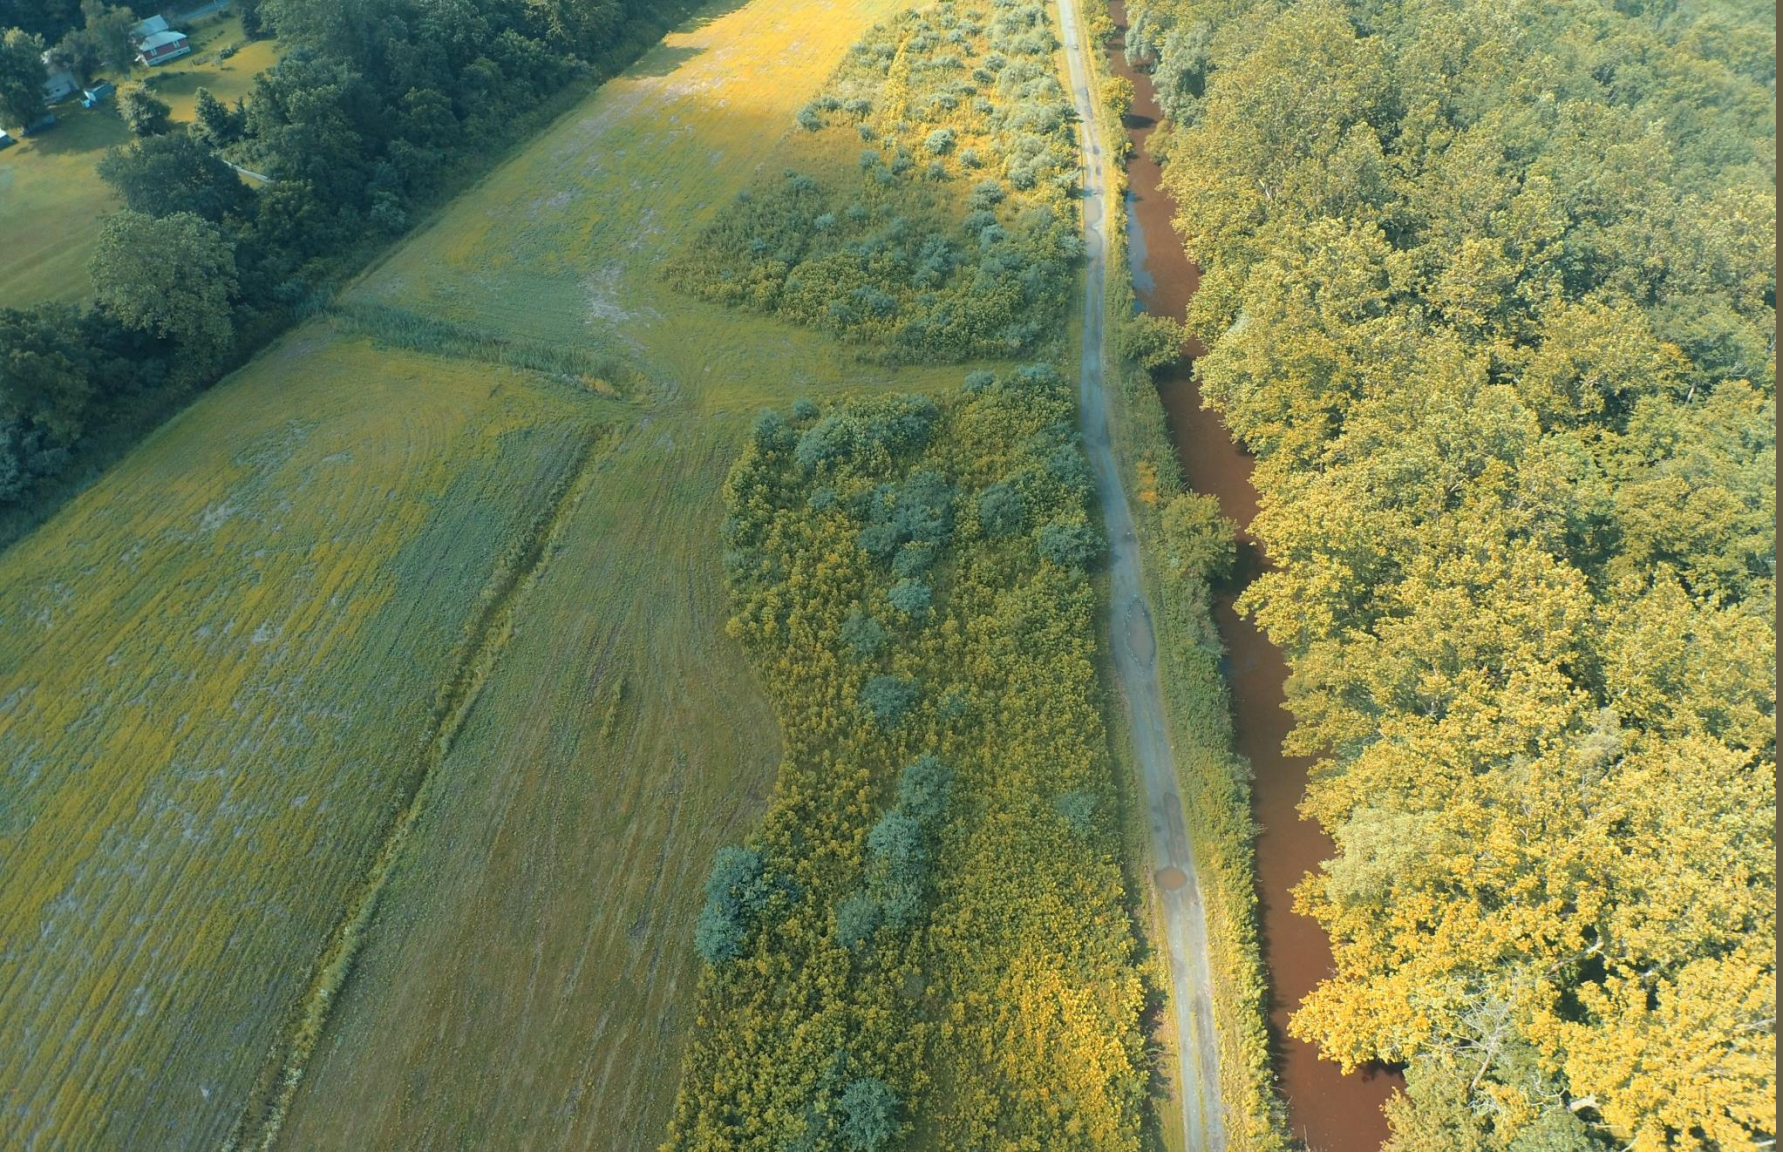
Site: Pre-construction

Looking south along the piques, note access road in the riparian zone, Autumn Olive in the passive forest, ditching in the wetland

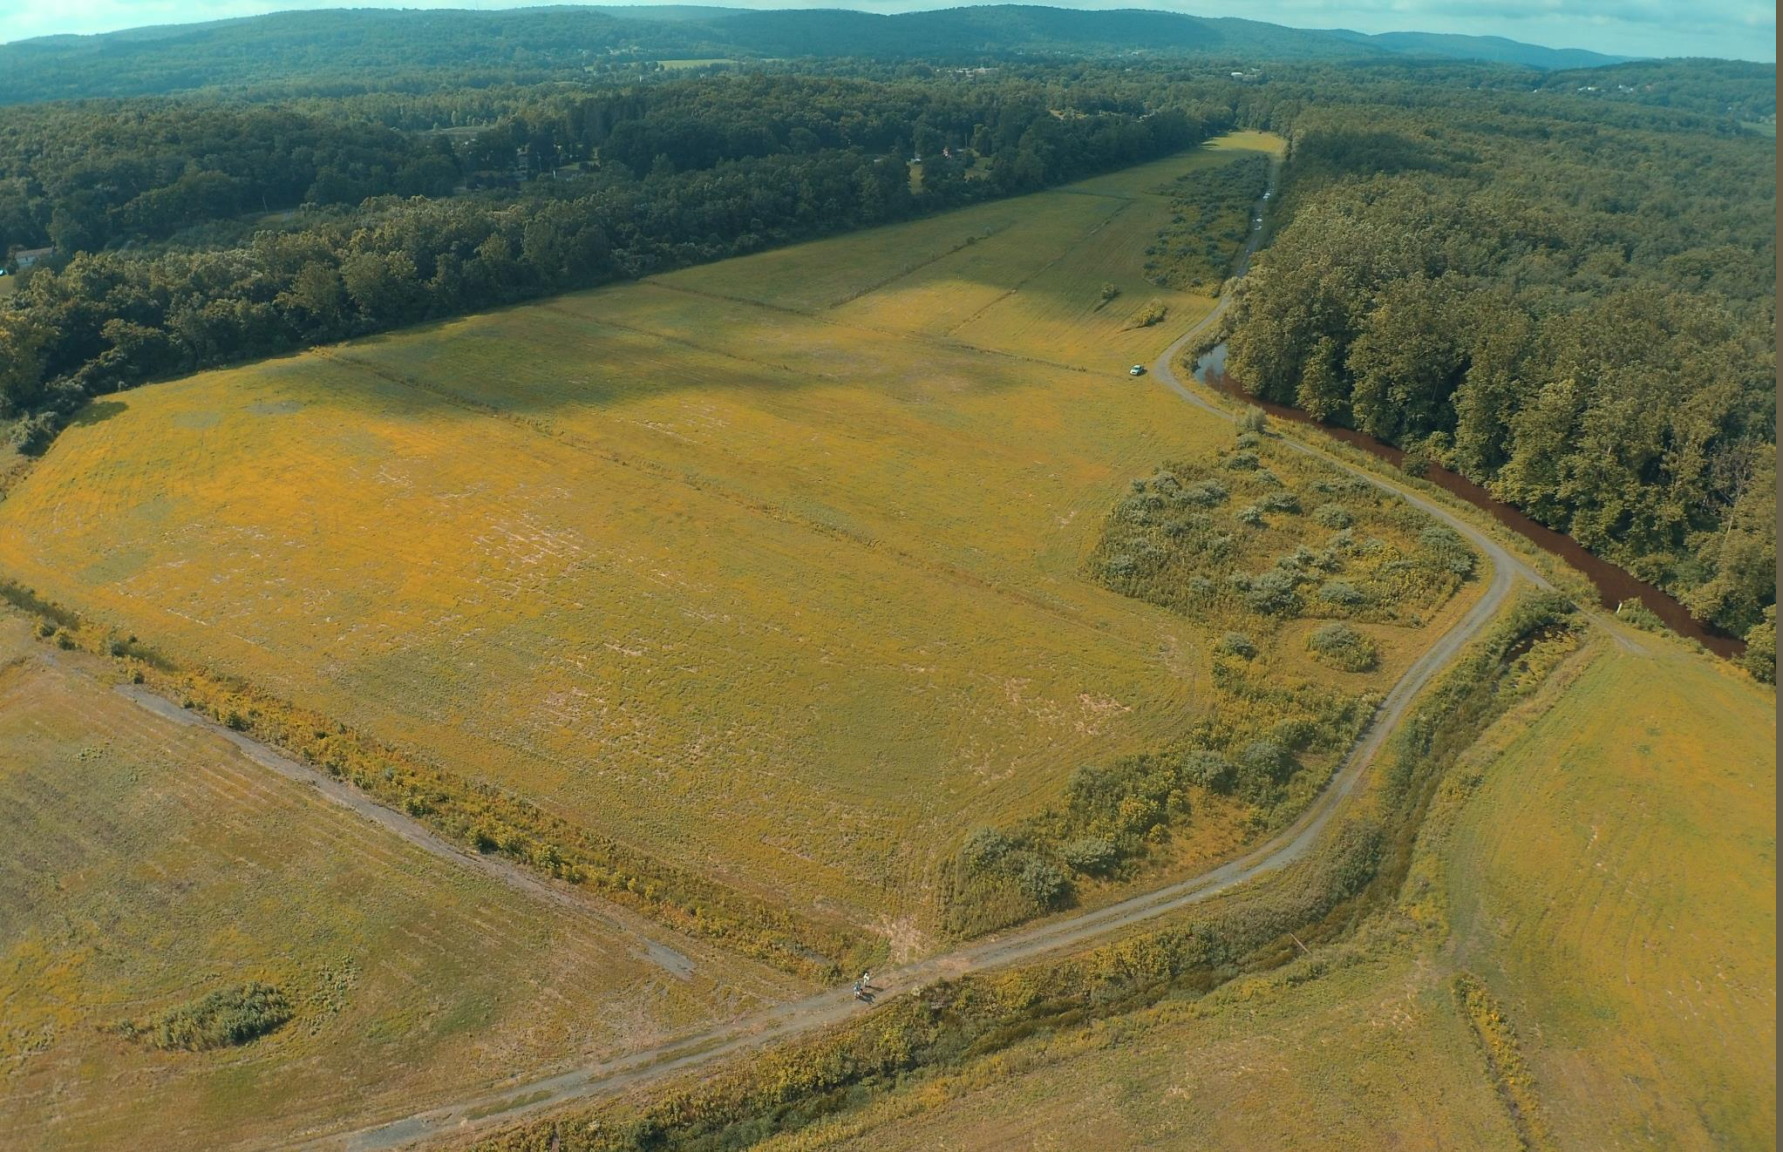
View of Agricultural Drainage and Roadways

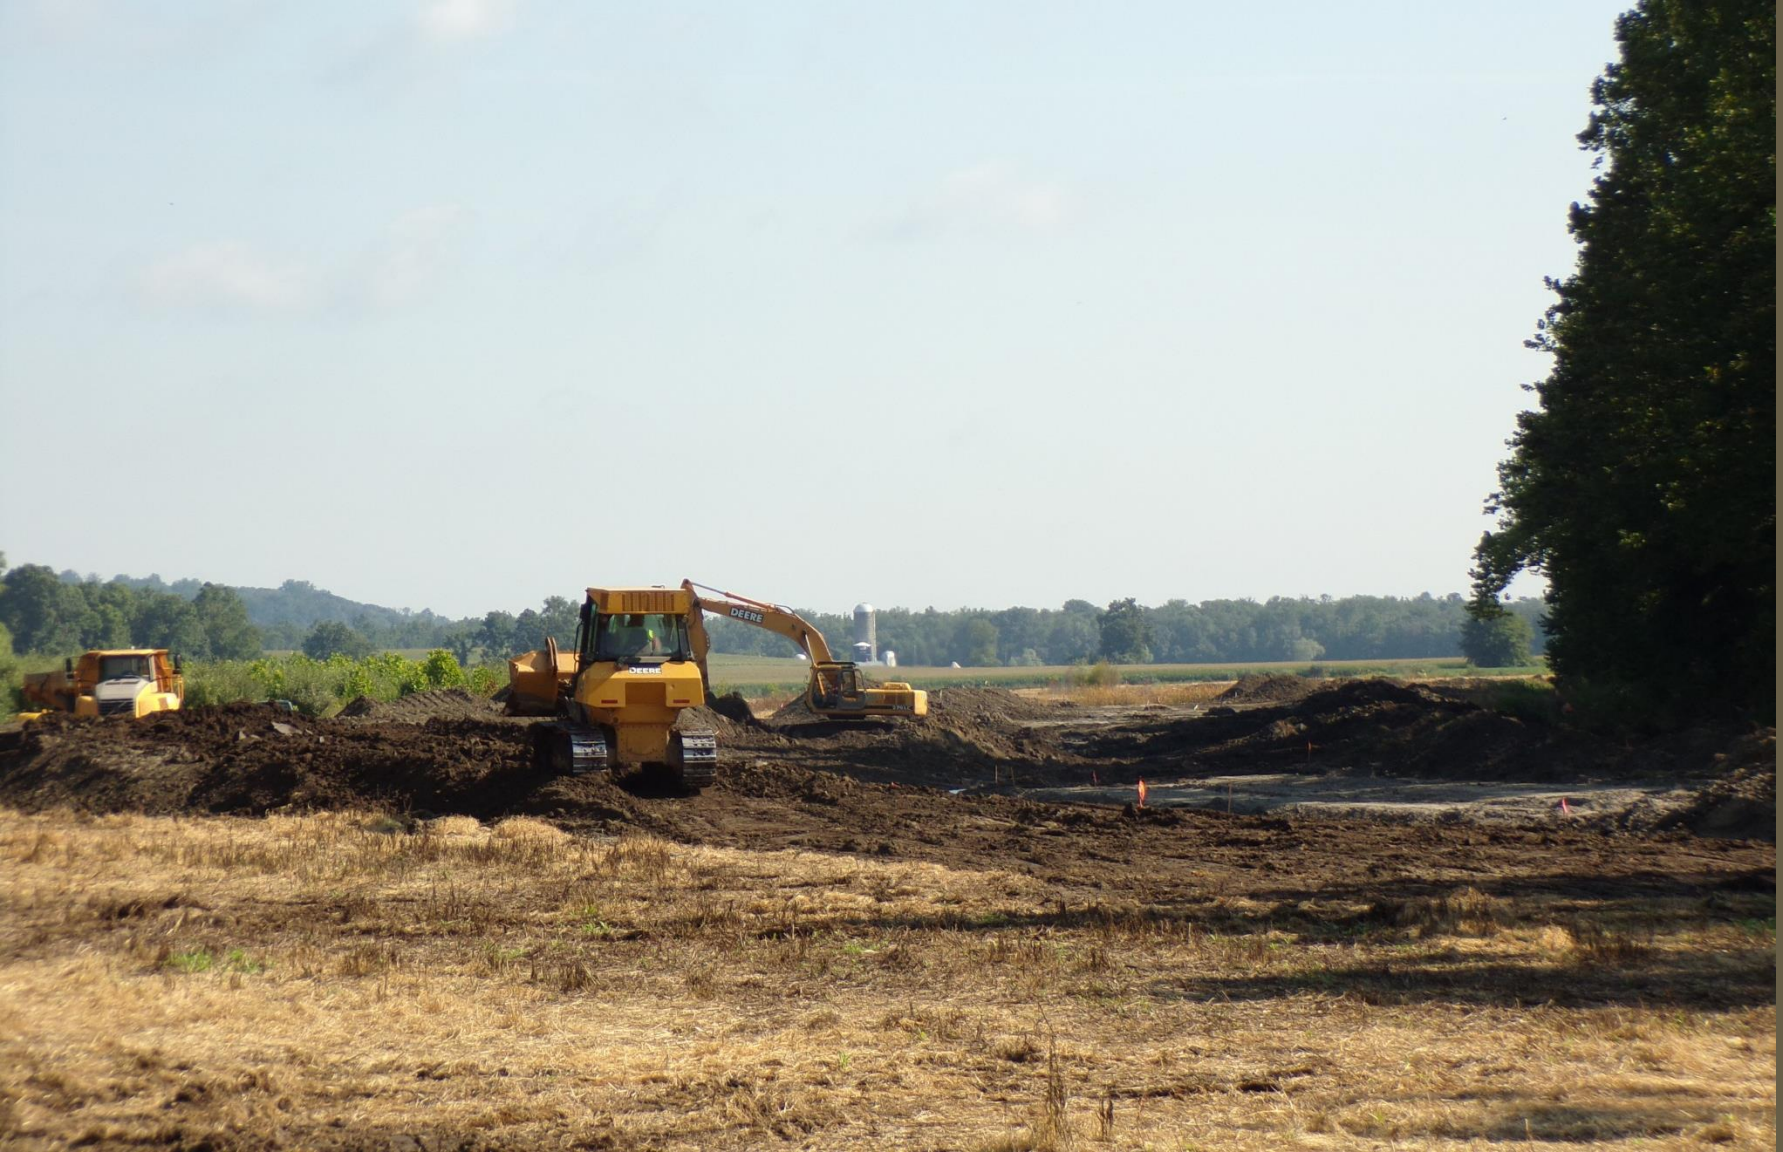
Excavation of Streams

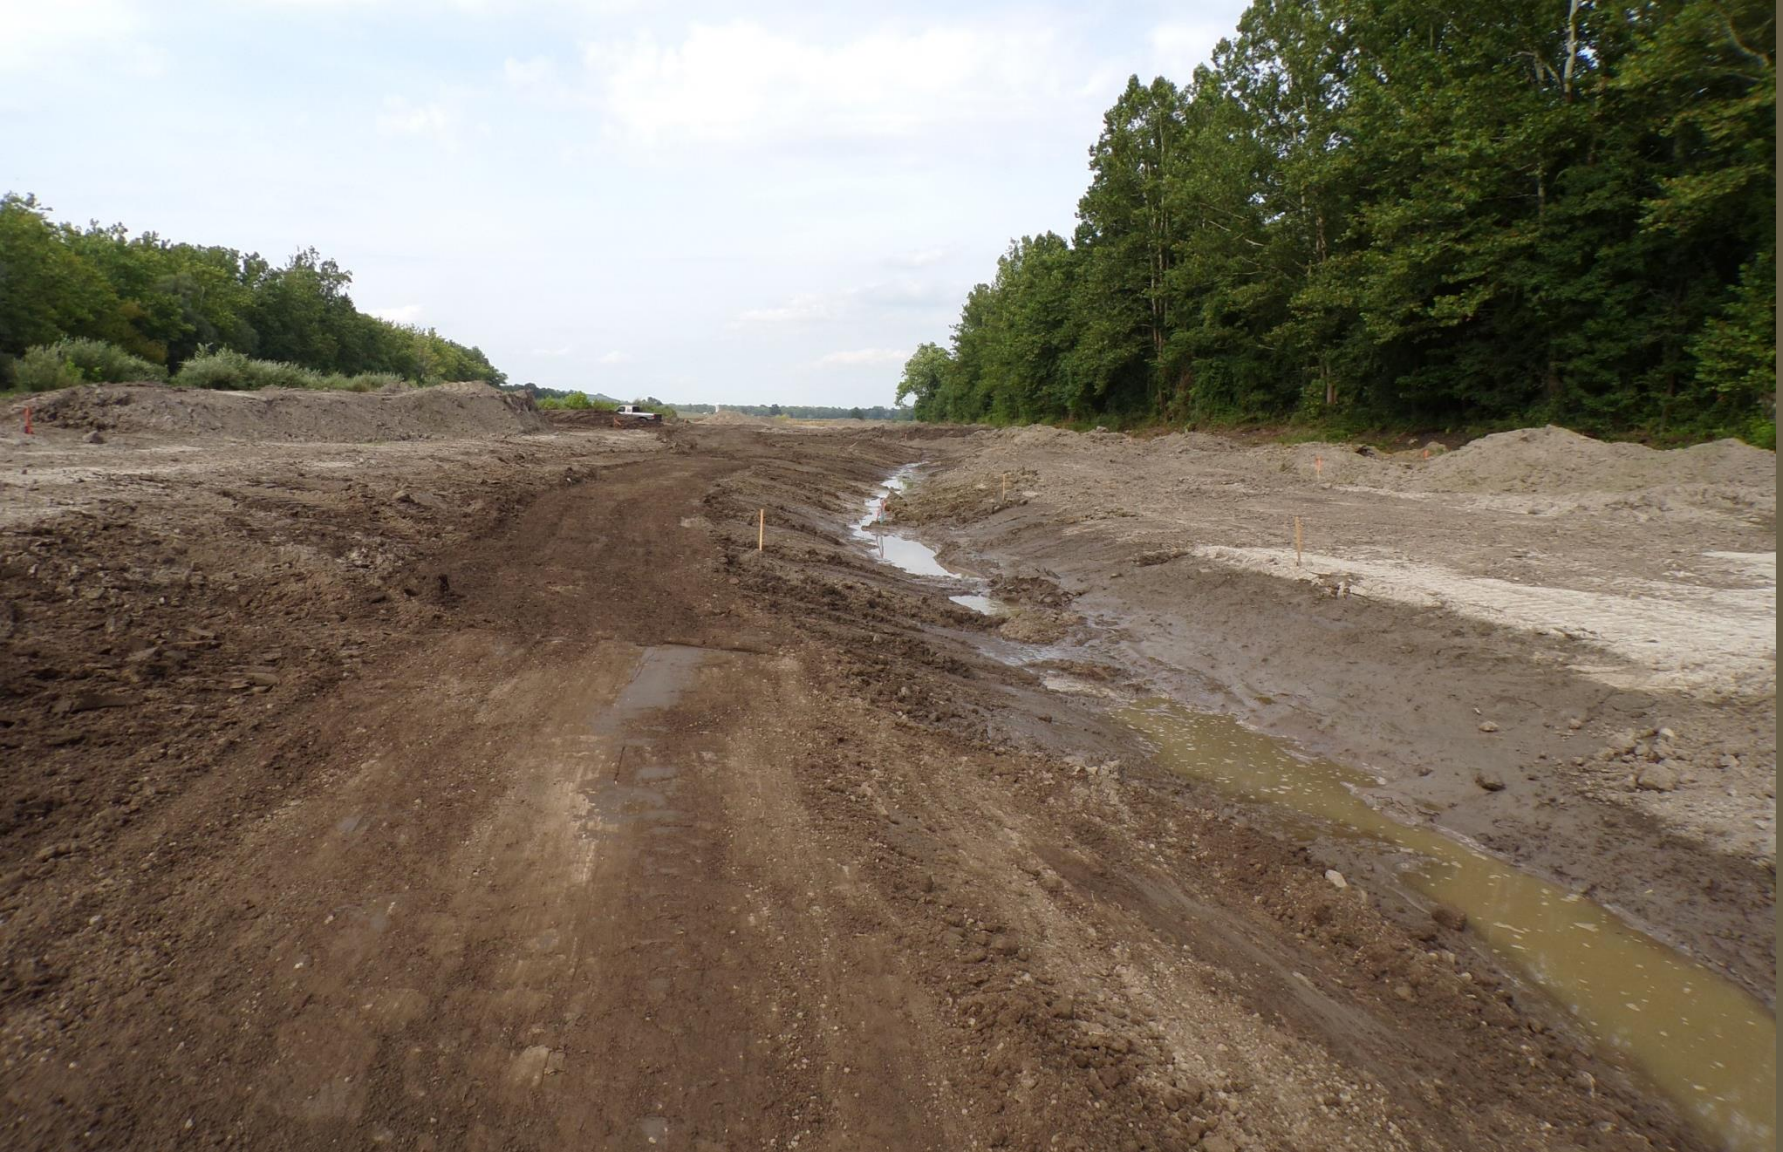
UNT Realignment- In Progress

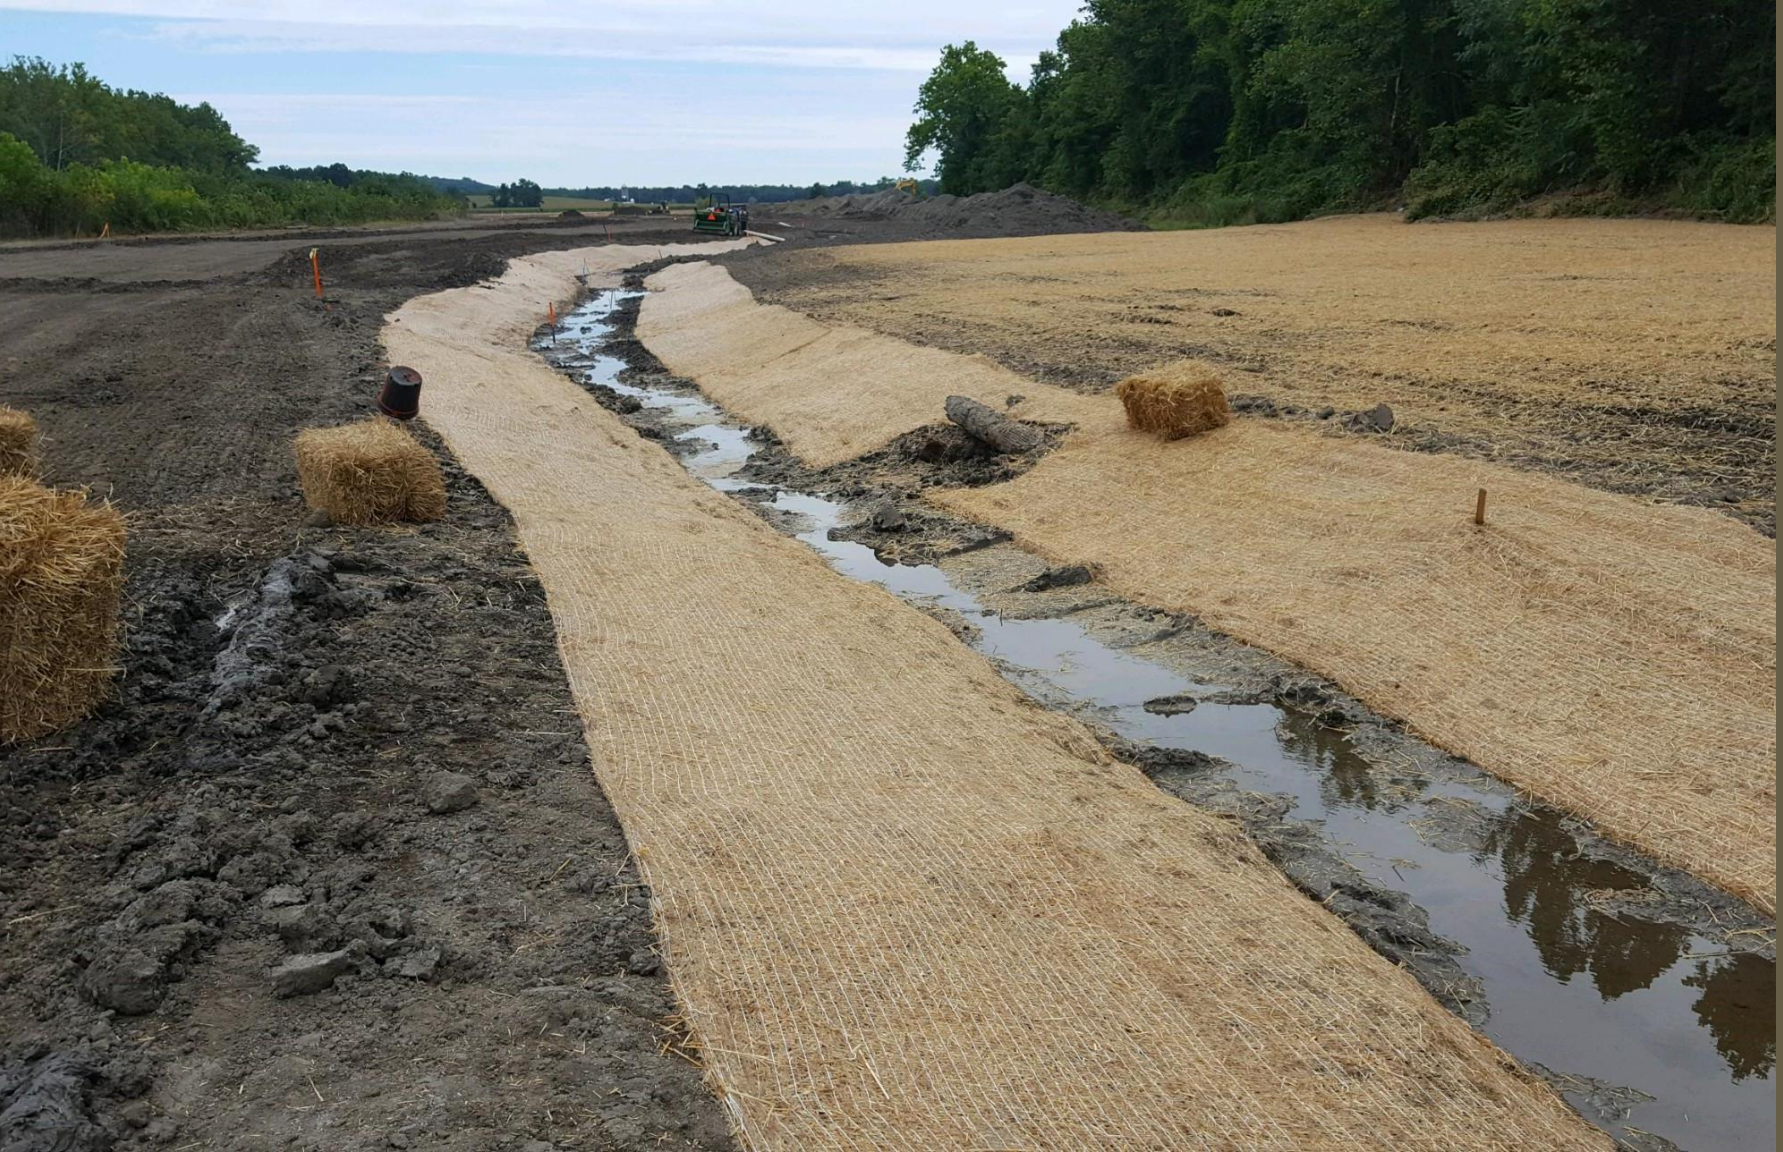
Stream Restoration Construction

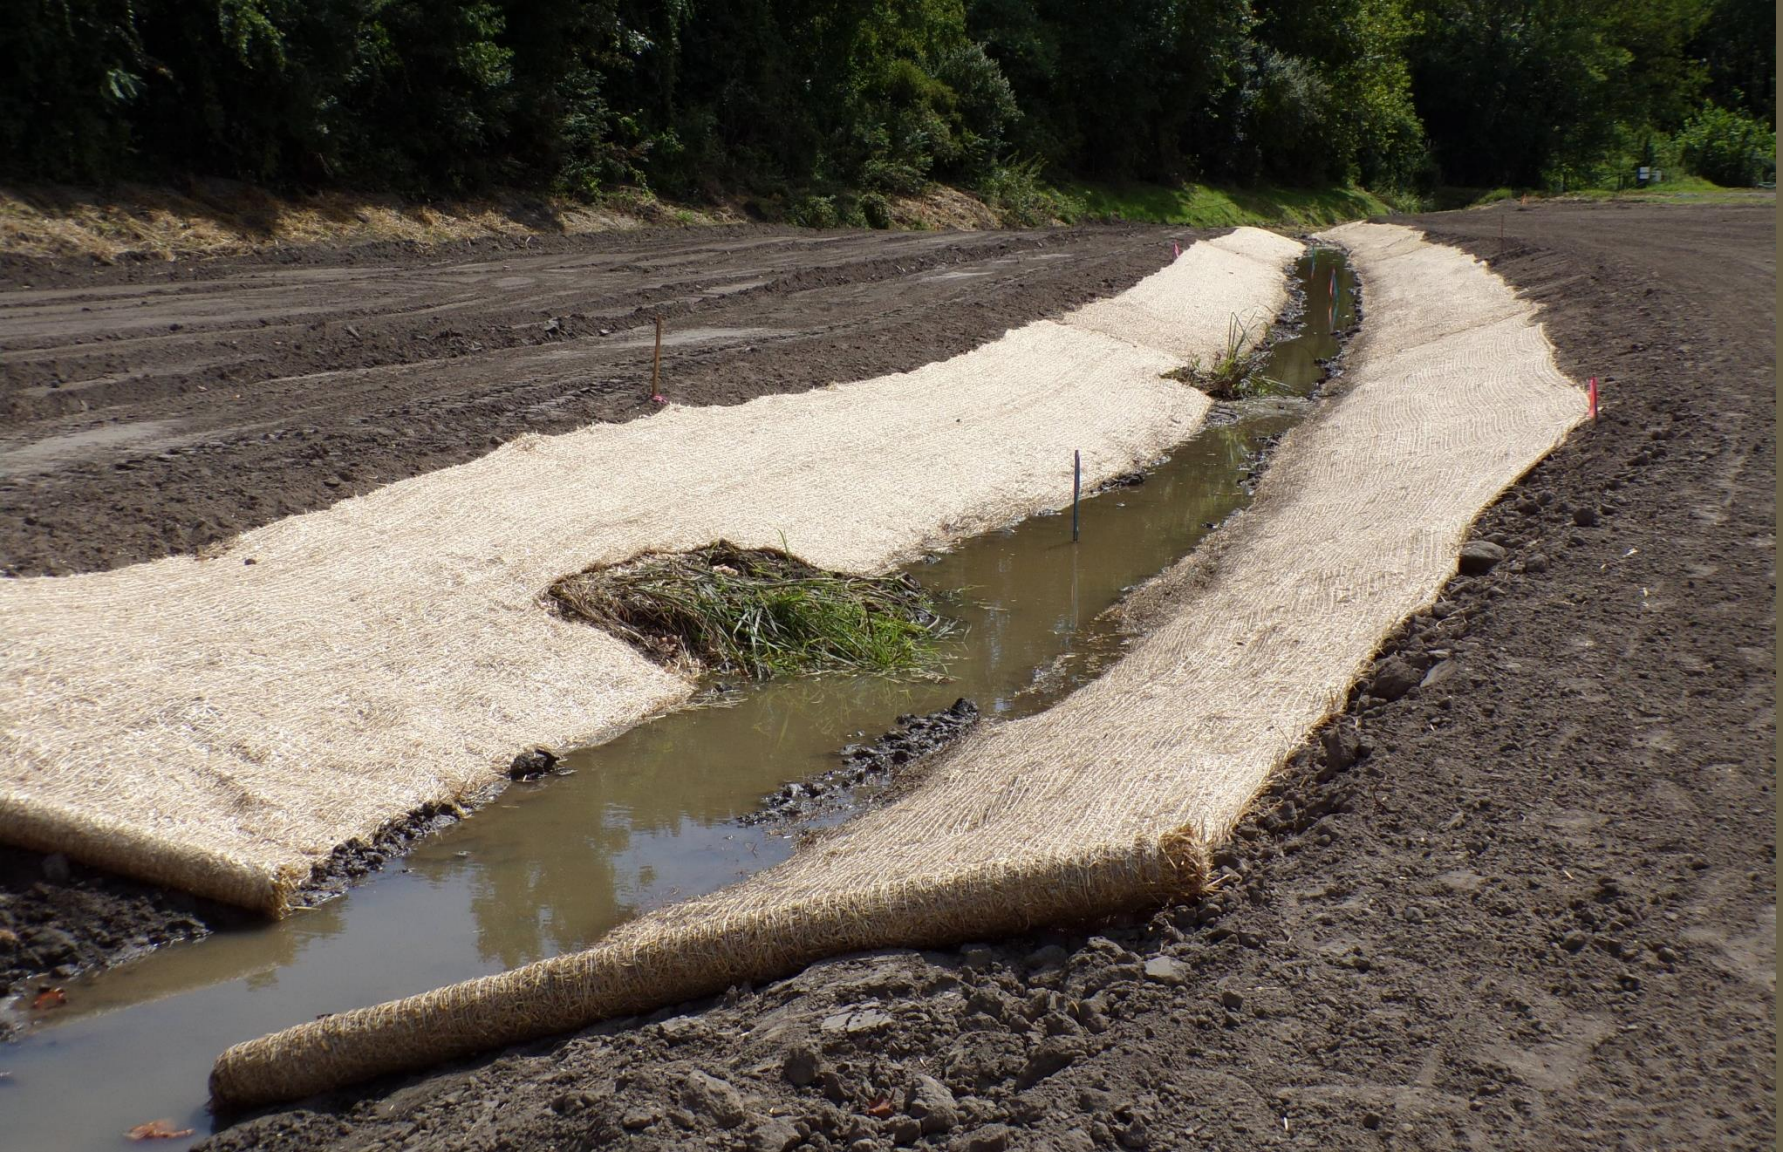
Stabilized Stream Realignment with Plant Salvage

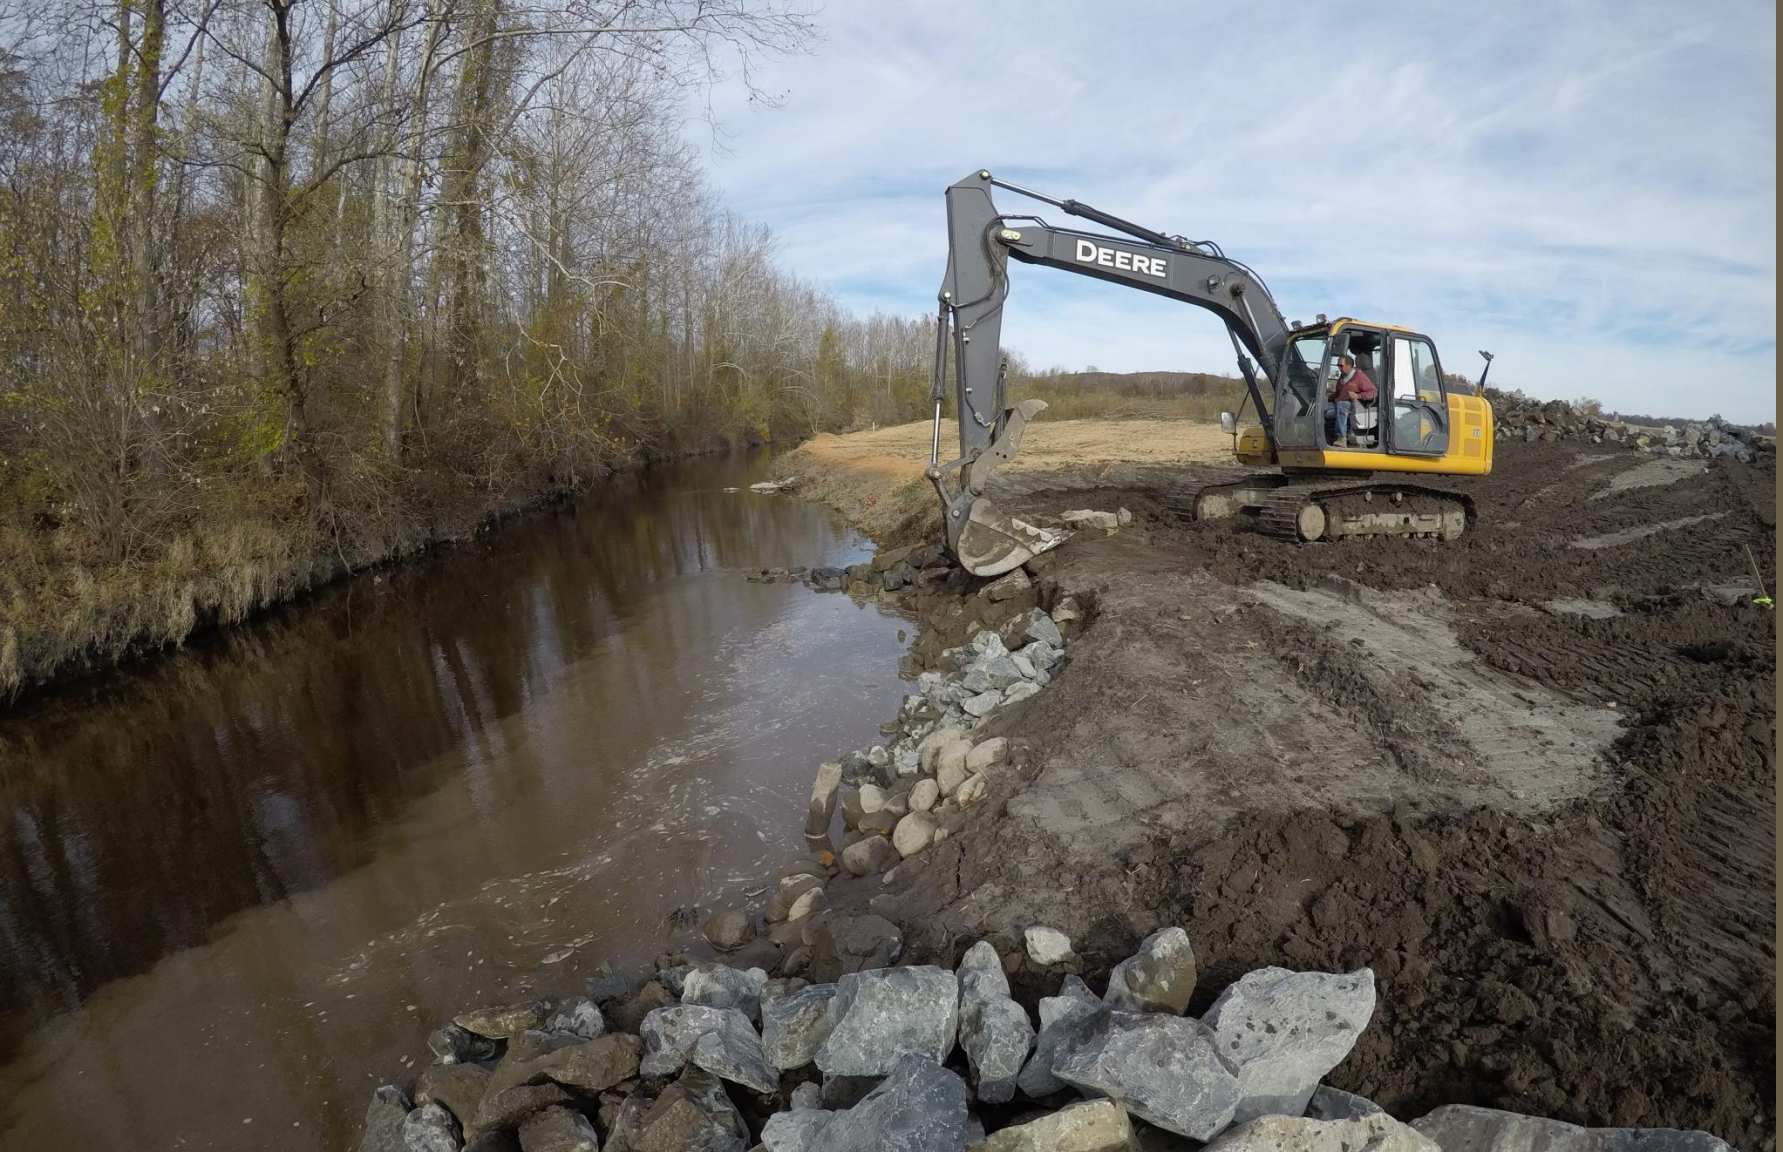
Bank Stabilization- Rock Vanes

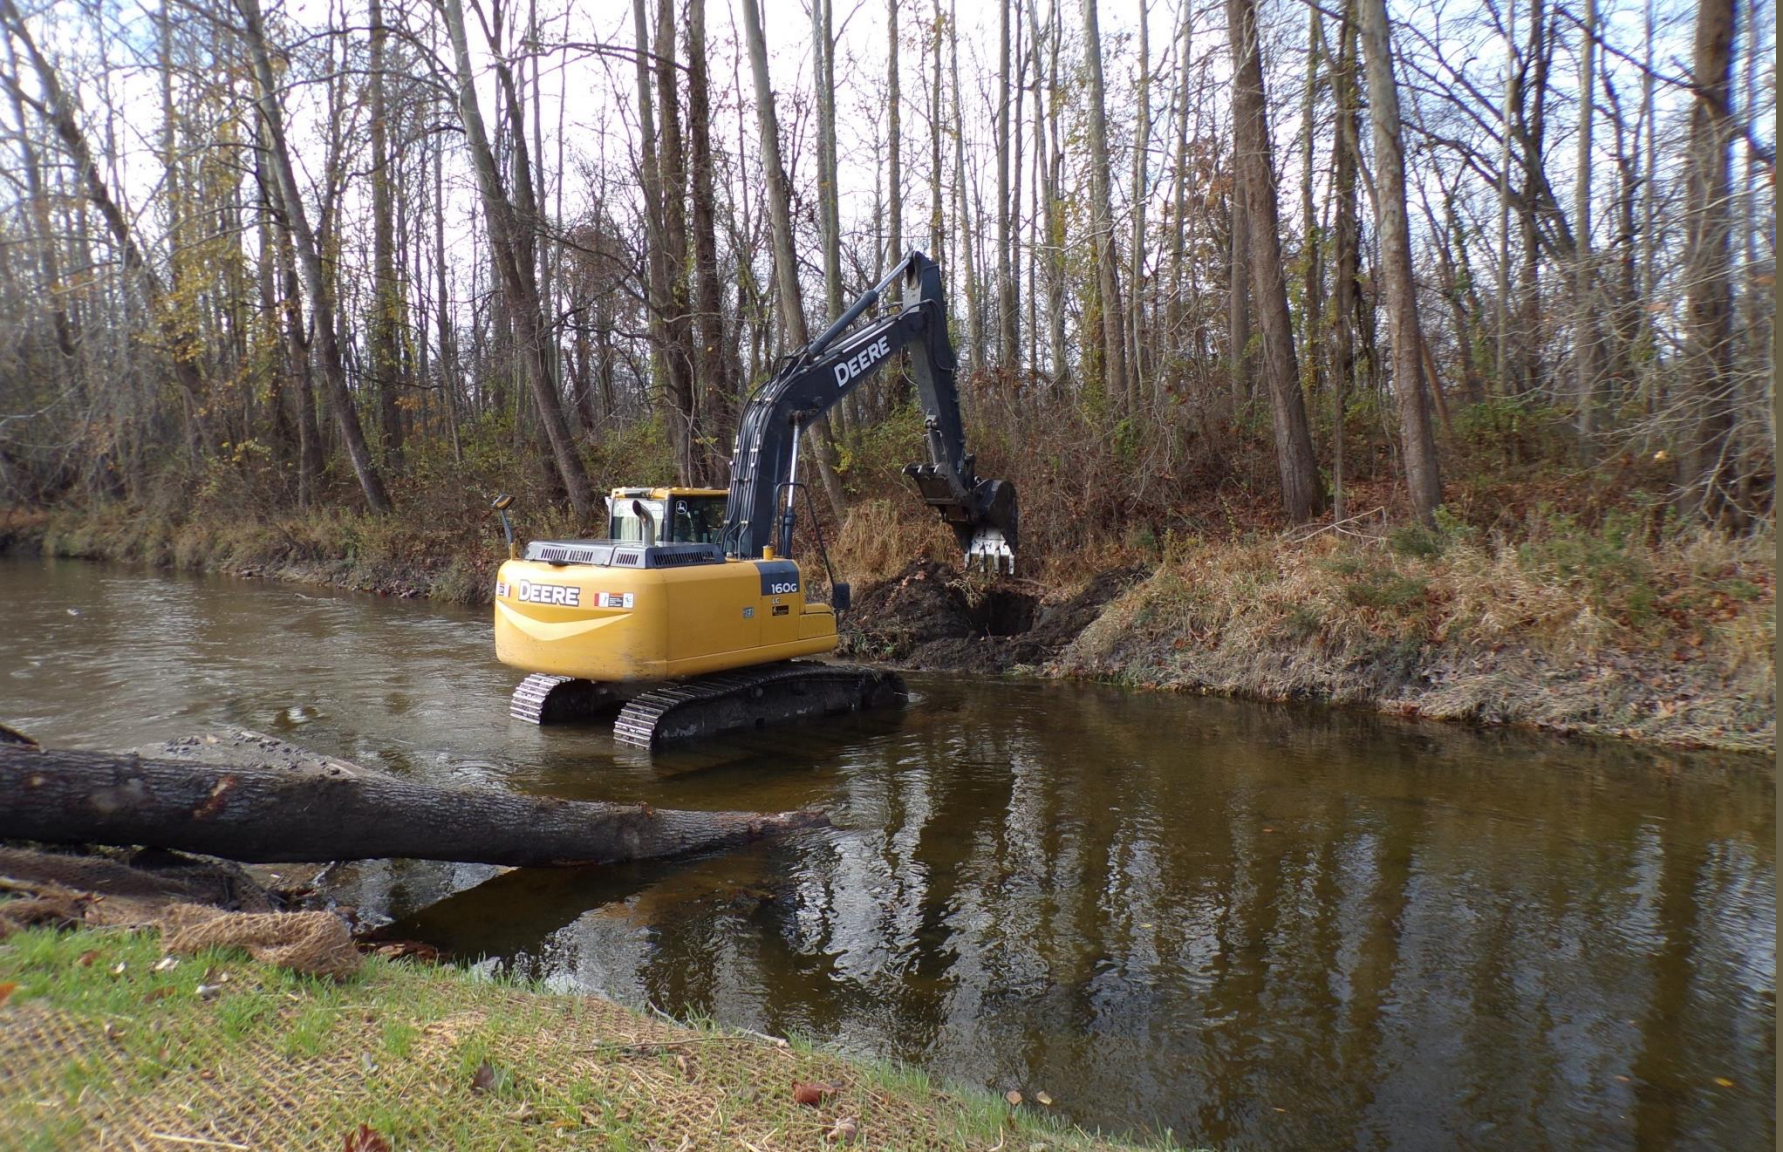
Log Vanes Installed within the Pequest River
