Pequest Wildlife Management Area / Kenco Acquisition

Kenco Wetland Restoration Project

Overview

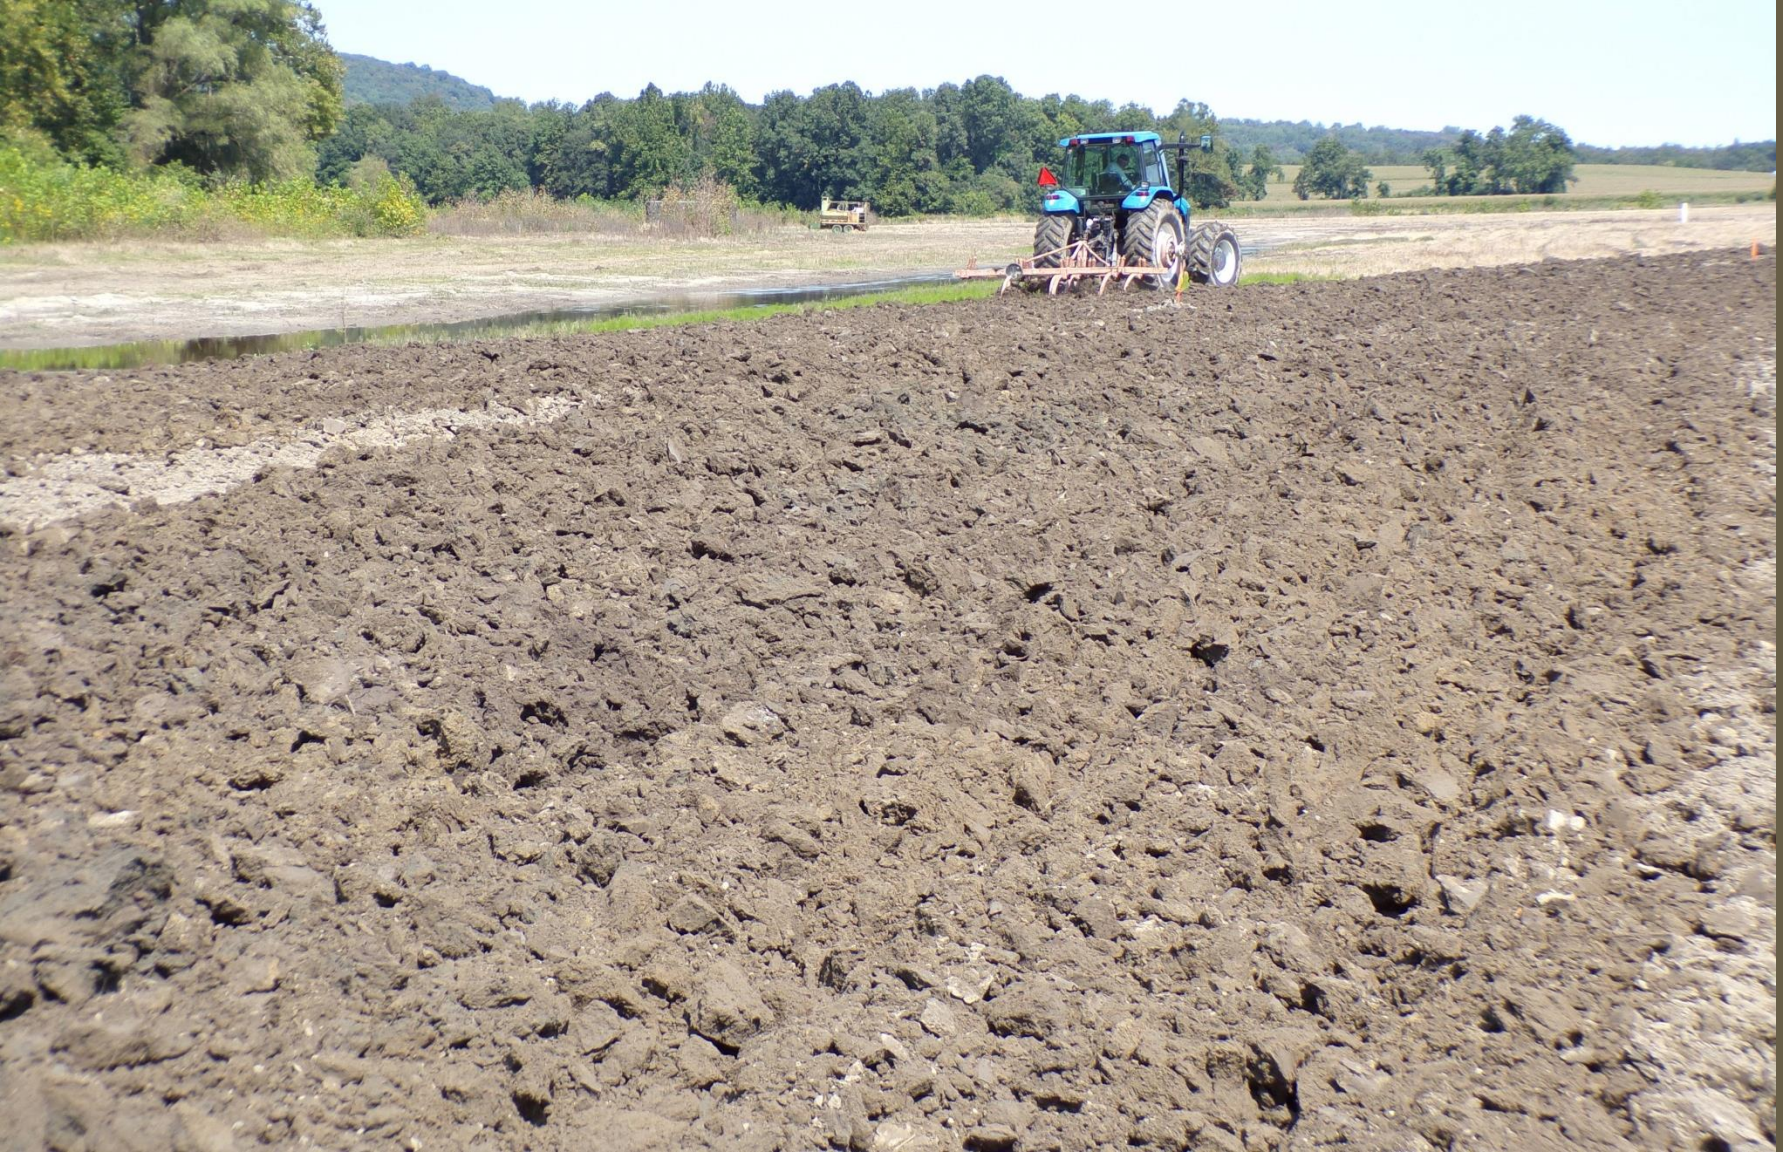
Decompaction prior to seeding.

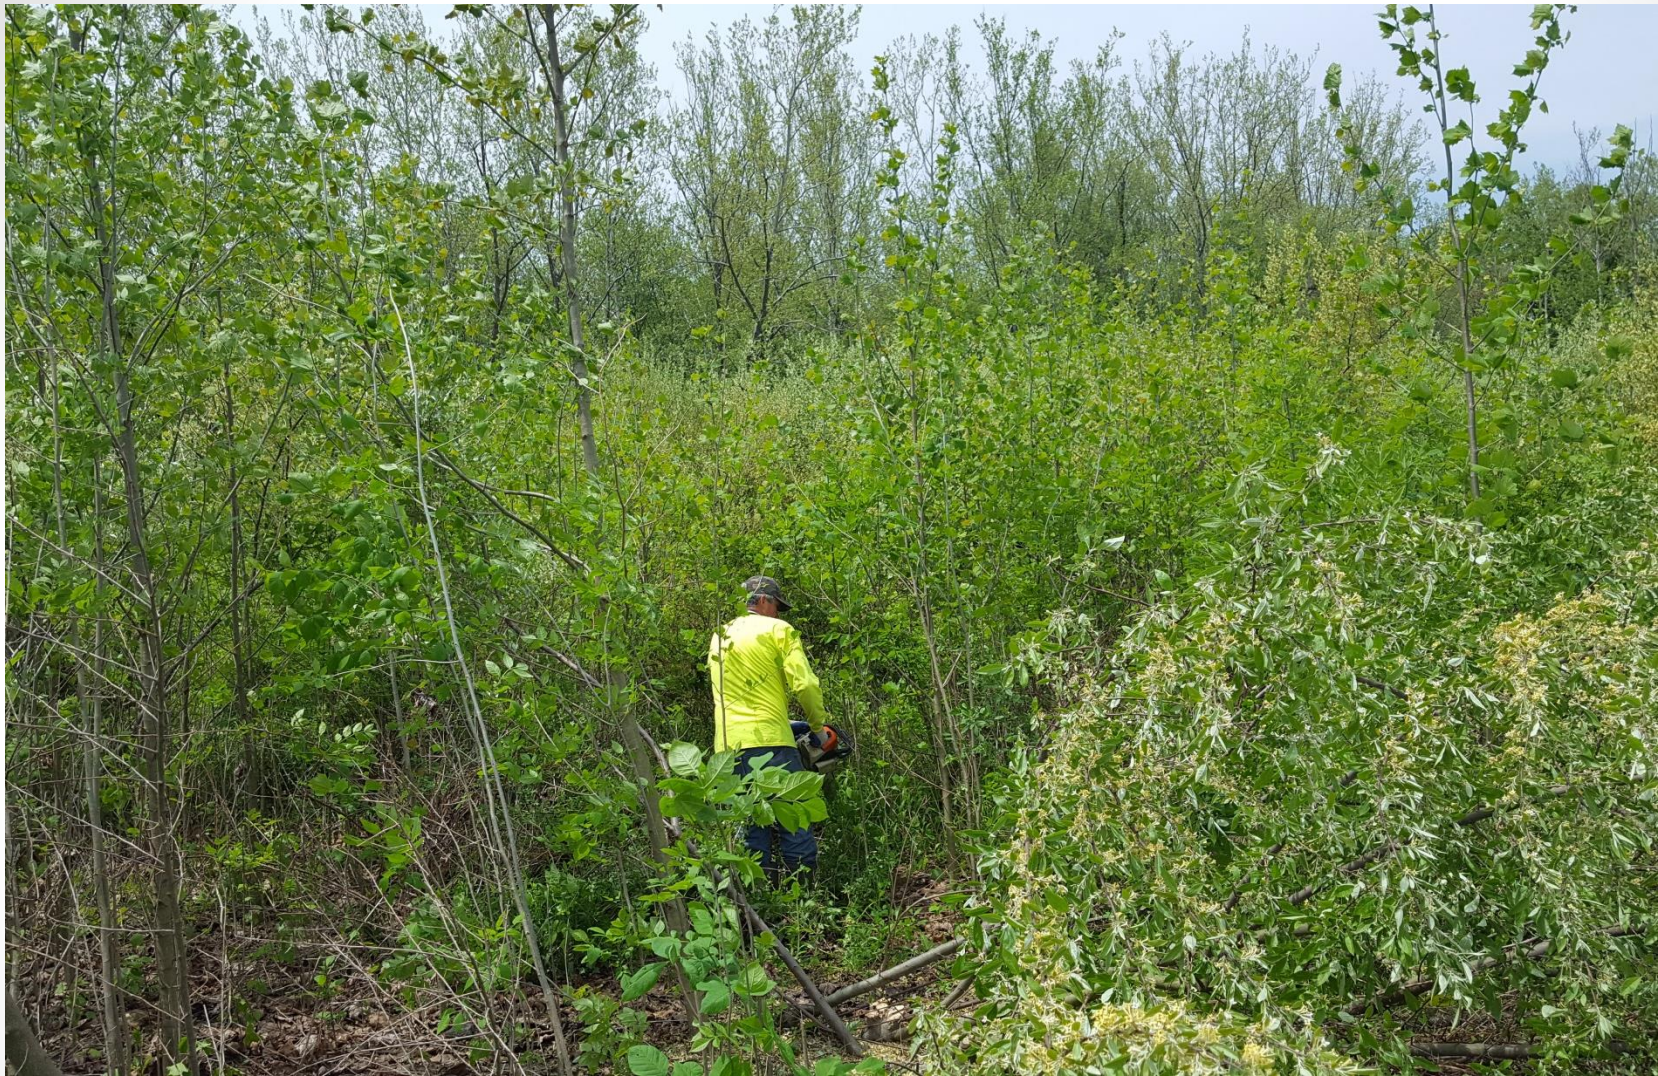
Cut and Stump Spray Treatment within Passive Forest Restoration

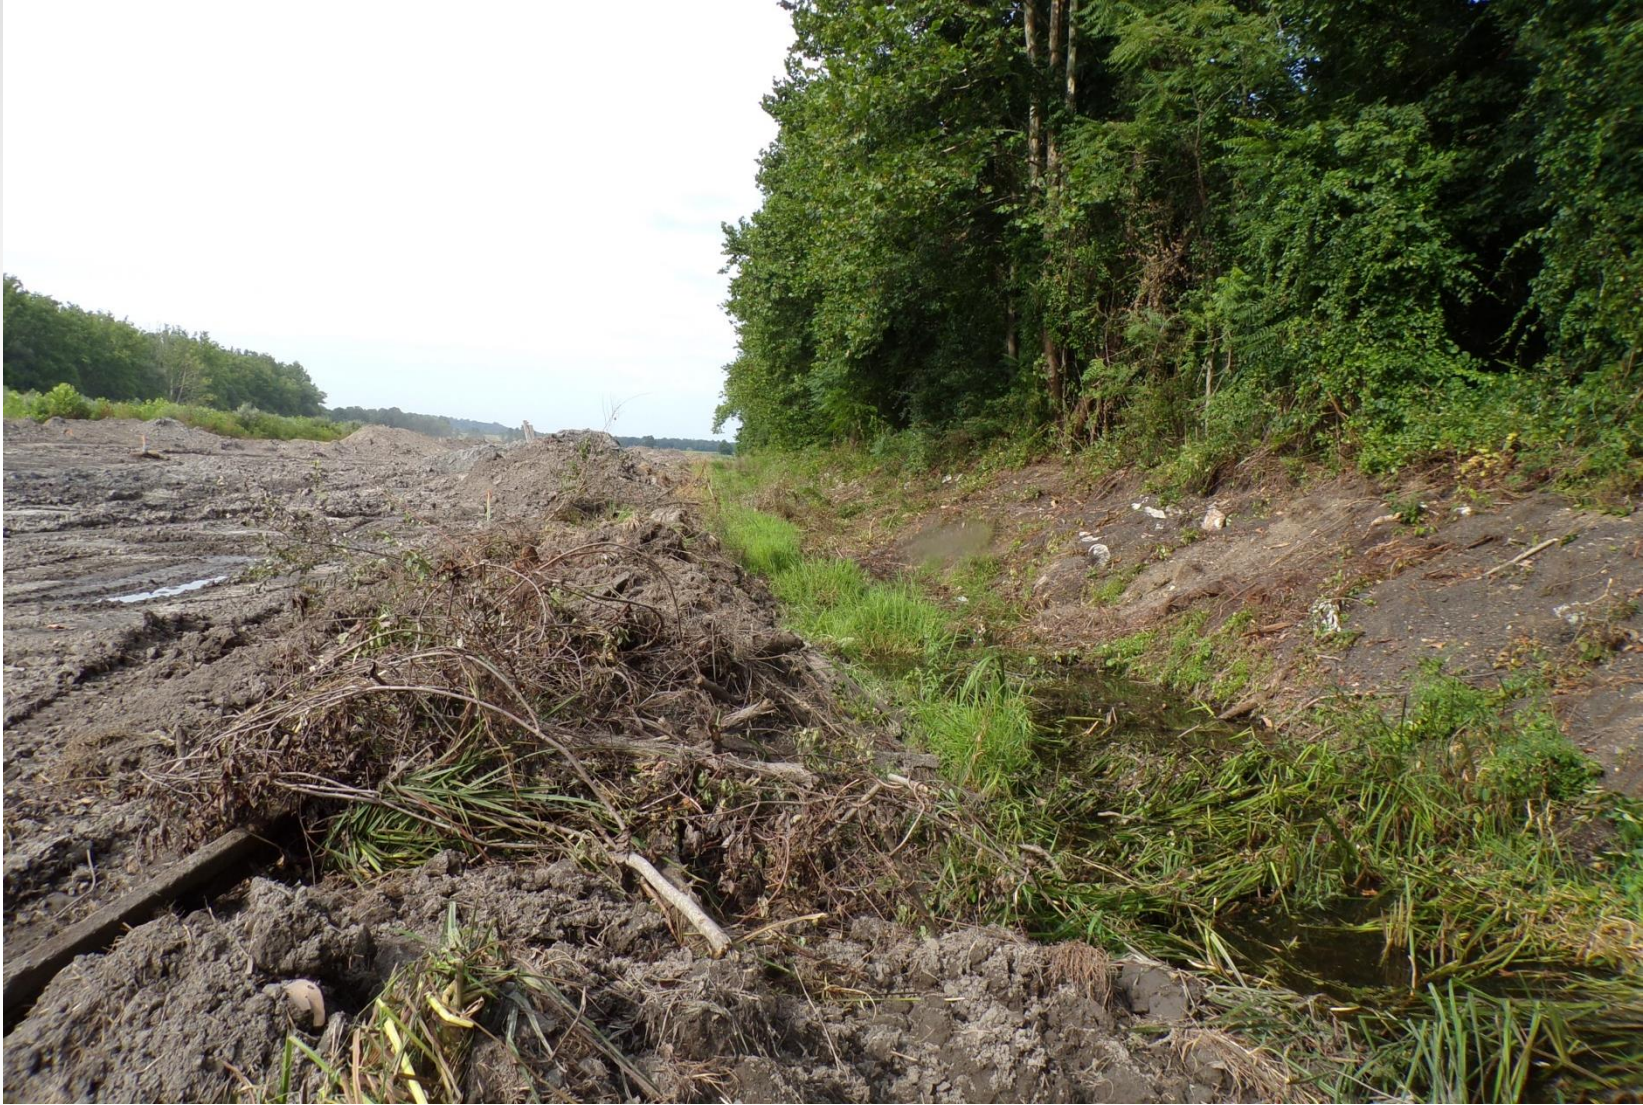
Clearing, Grubbing, Excavation, and Burying of Invasives

New Topsoil, and Seeding with Invasives

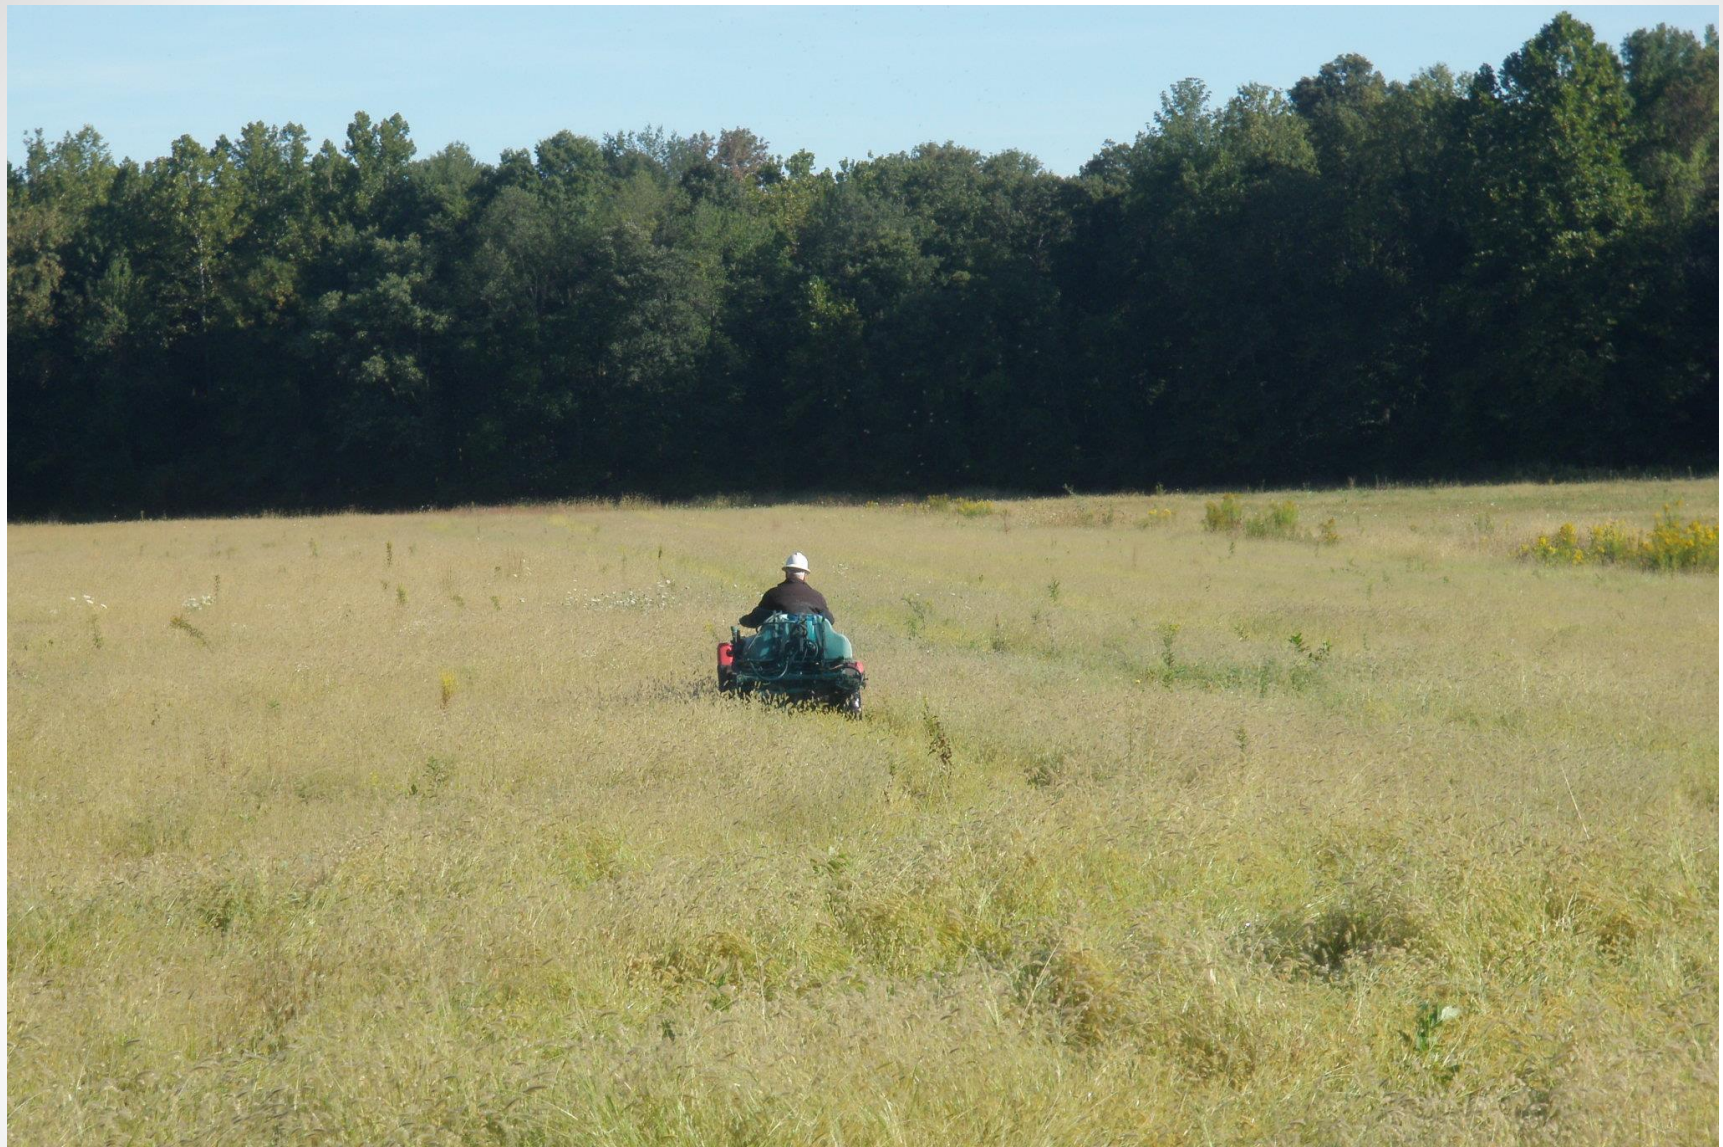
Site Wide Mow and Herbicide Application- Soil Sterilization

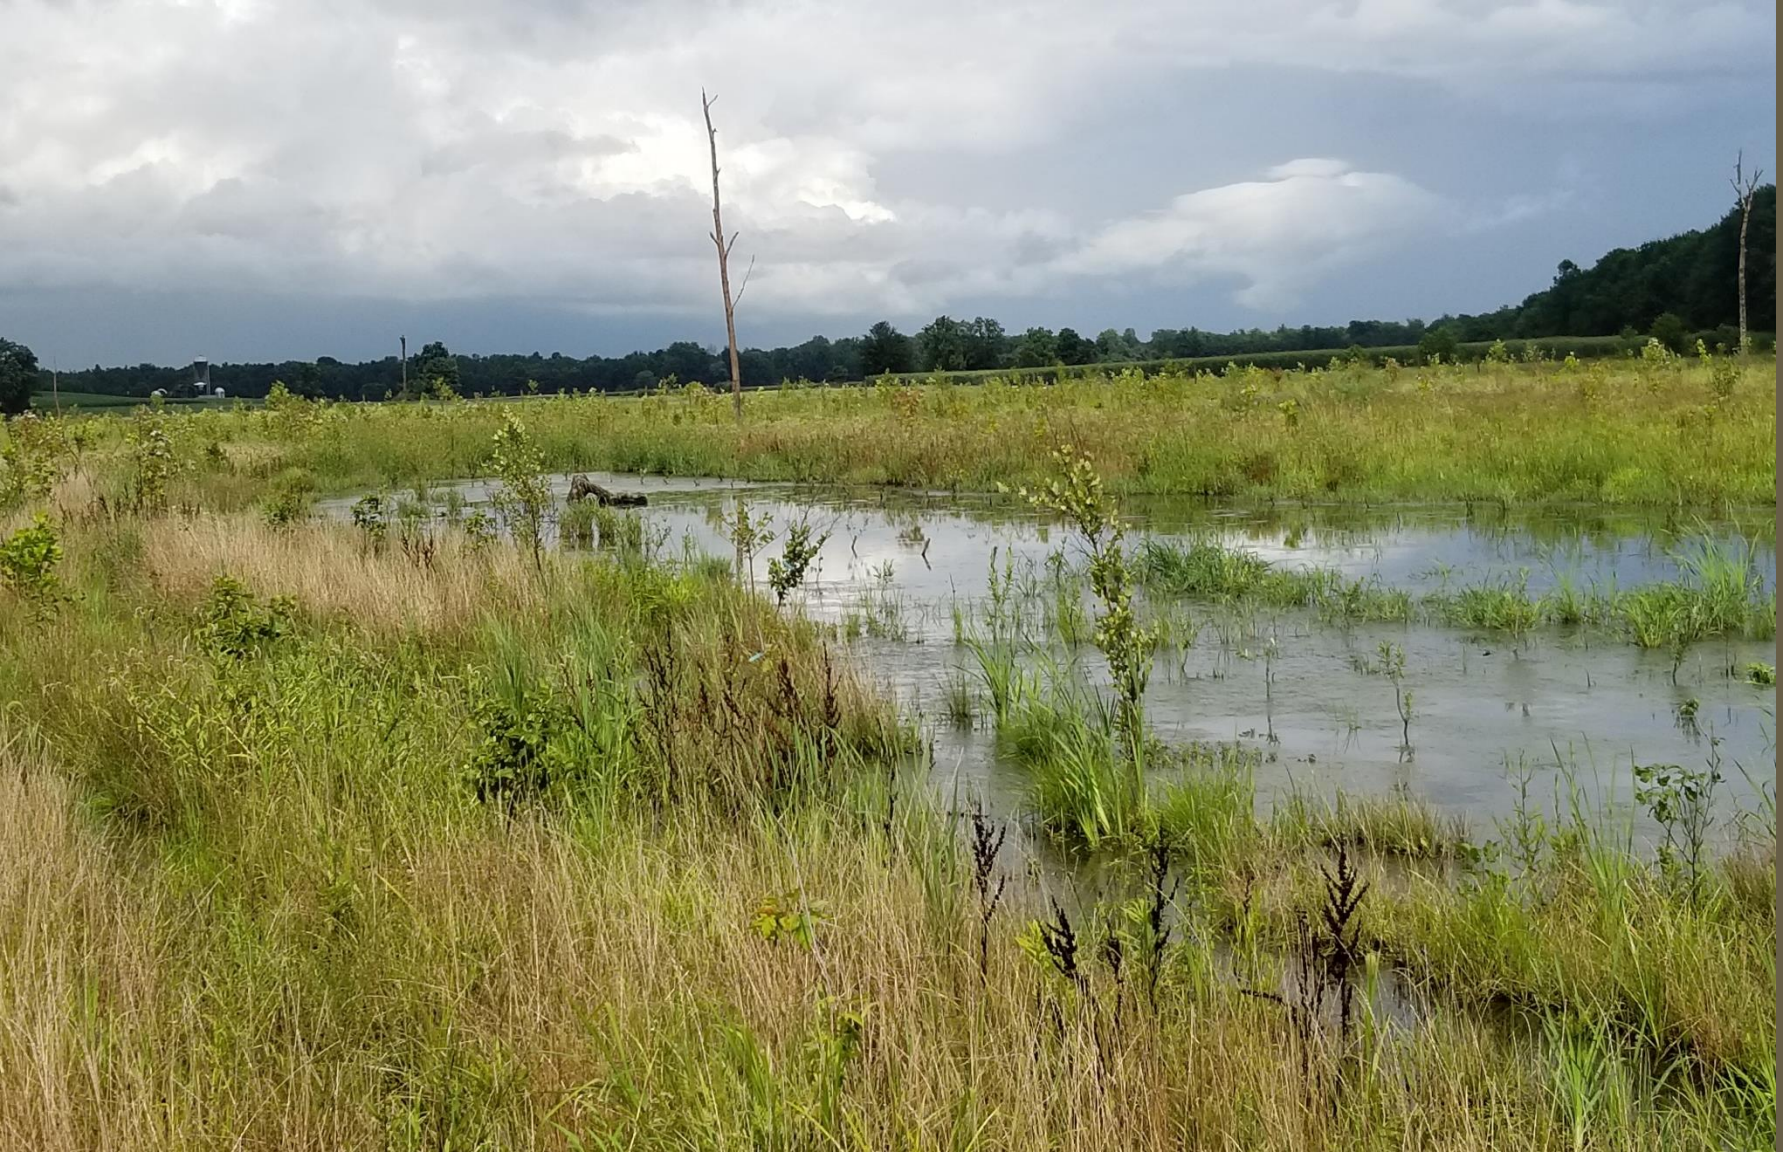
Change in surface water aids in the control of invasive species!

Sometimes creates new problems (Common Reed or Reed Canarygrass)

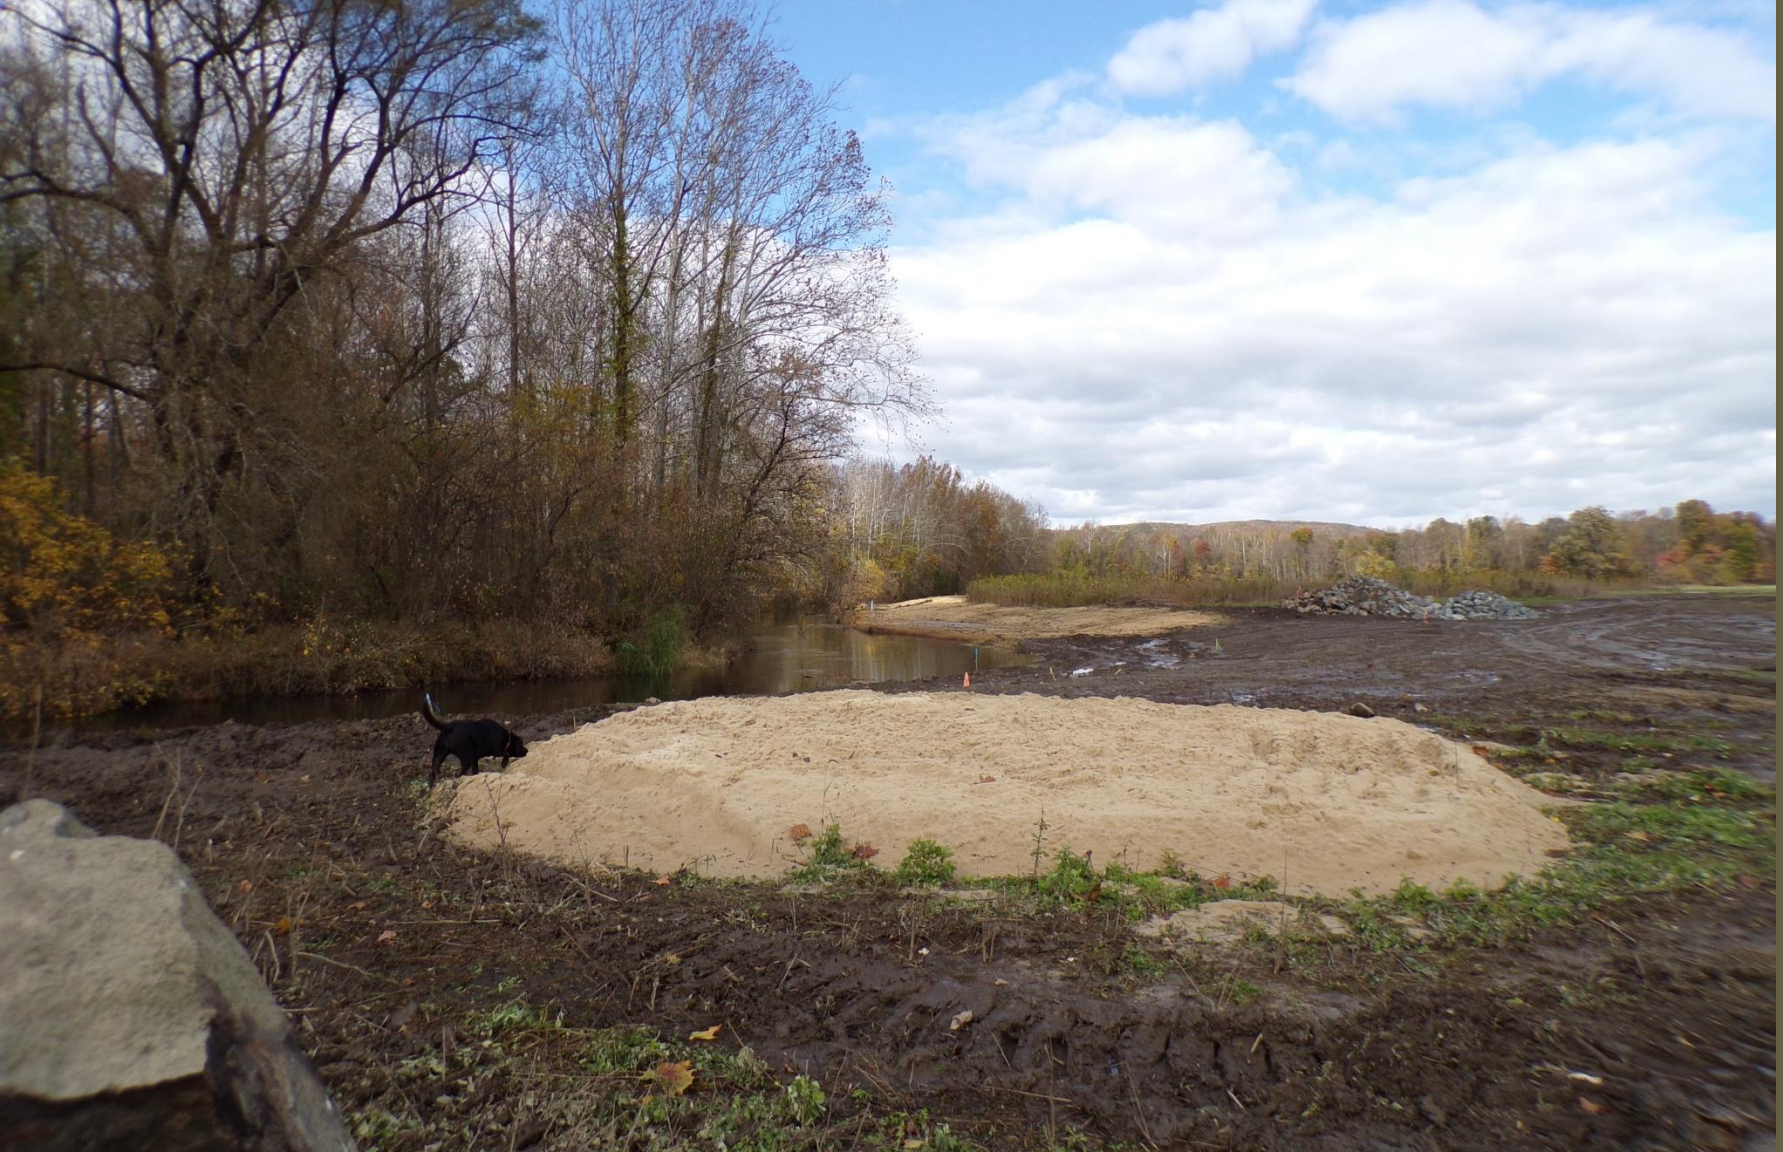
Wood Turtle Nesting Mounds

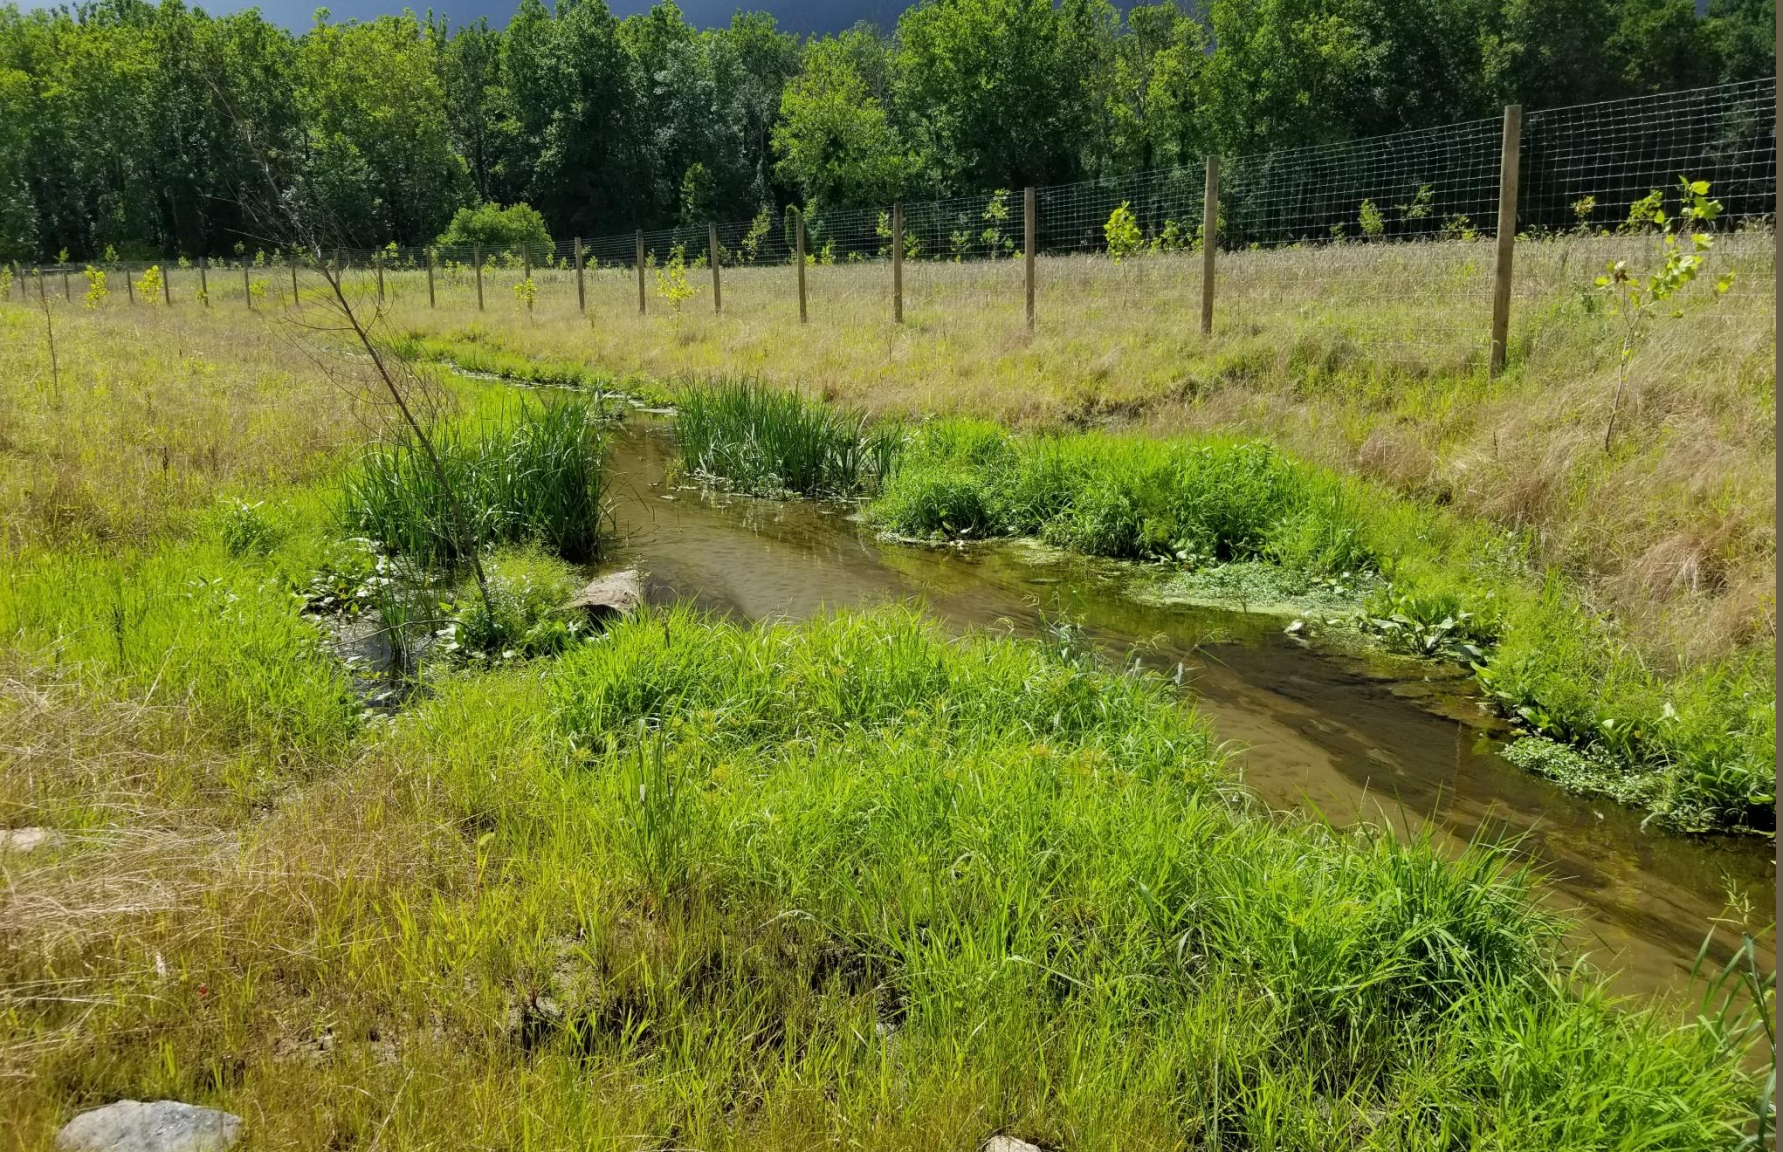
Realigned UNT of the Pequest River- plant salvage

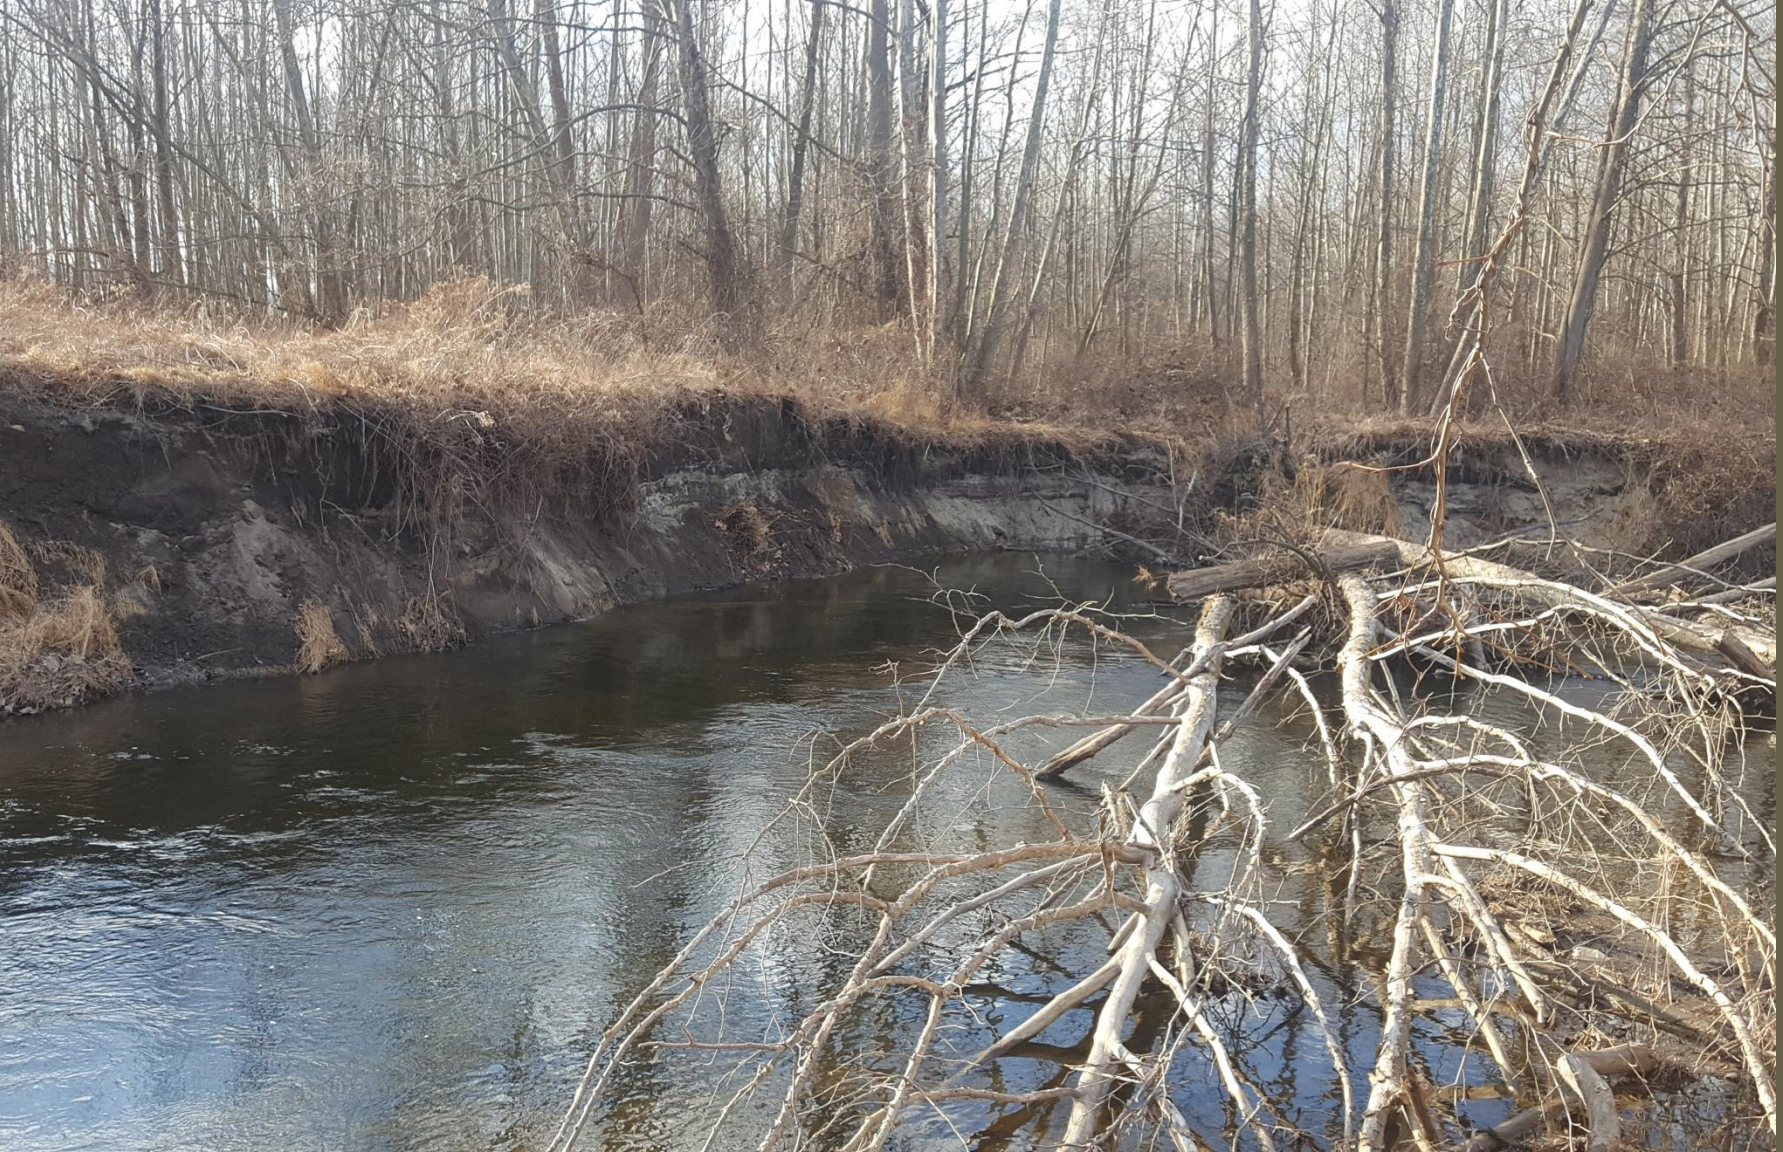
Pequest River Bank: before

Note heavy erosion

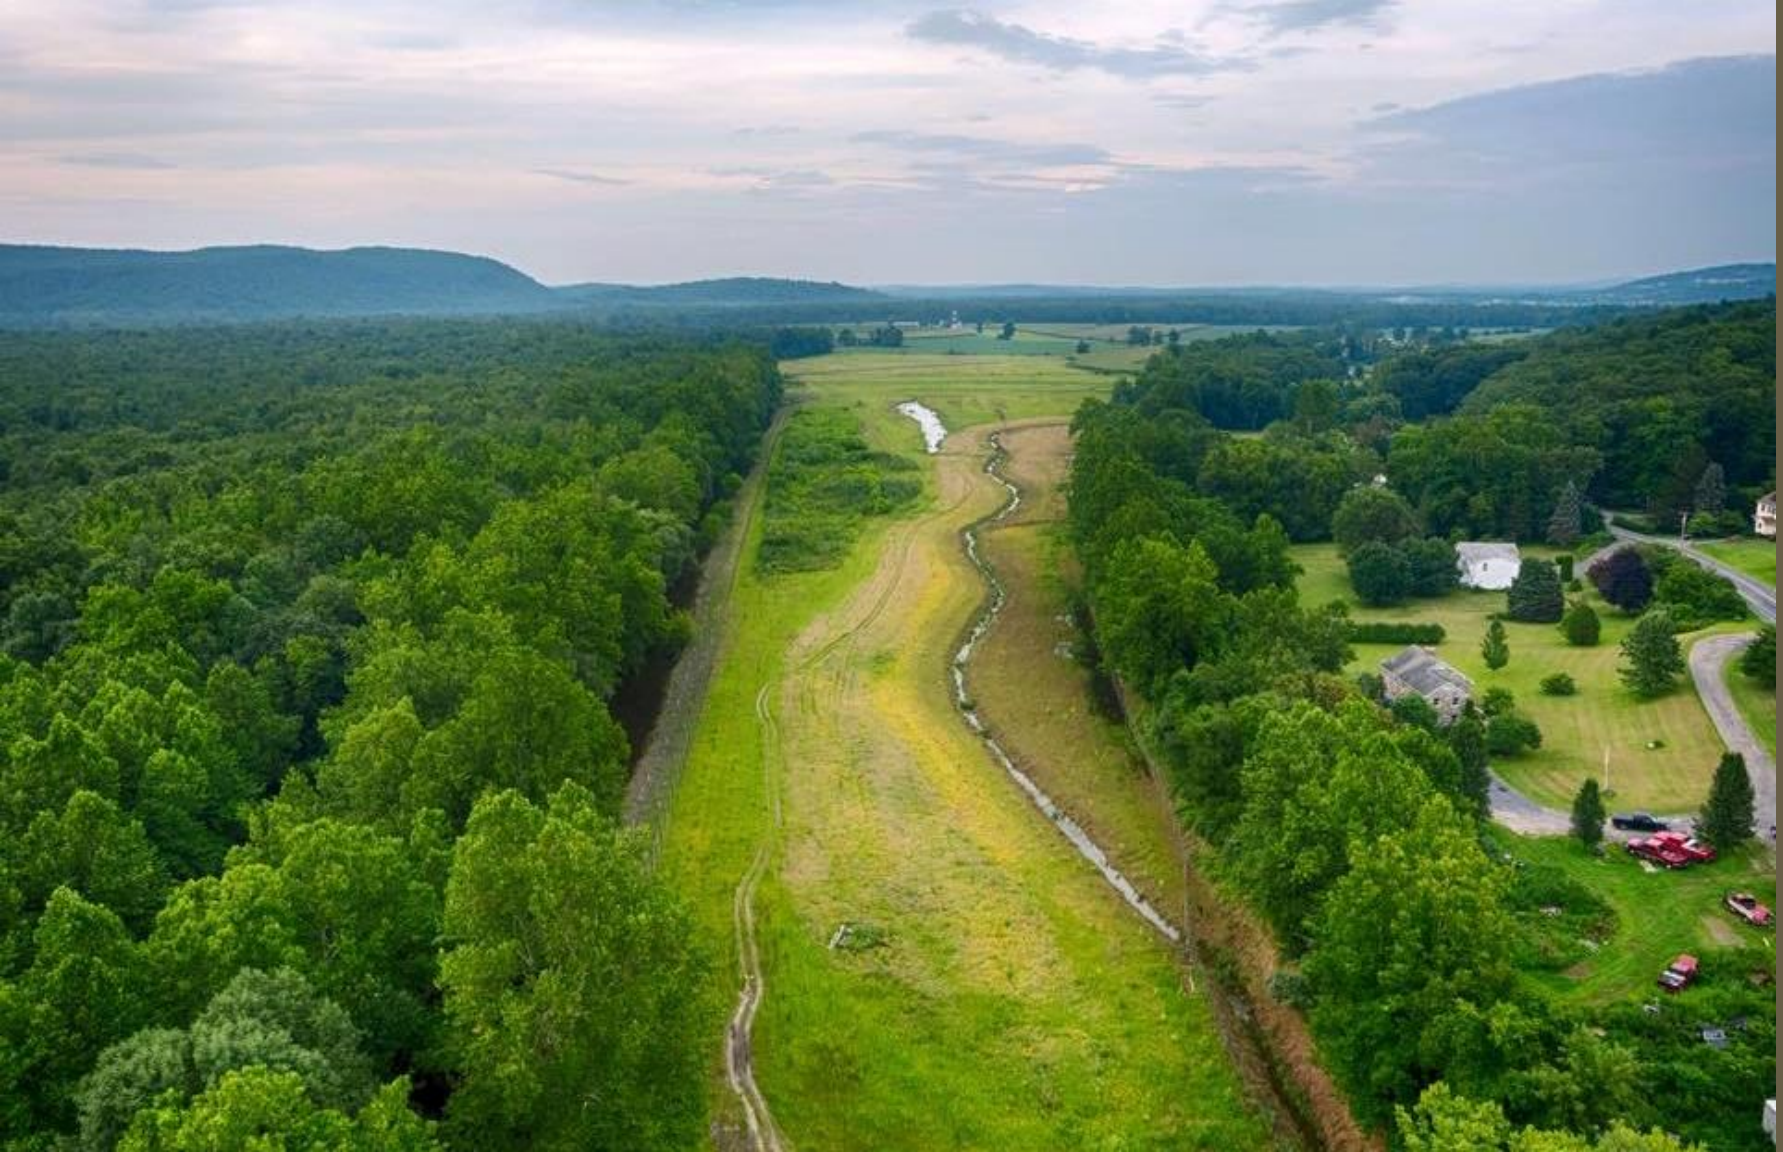
2018 Construction Completion

Aerial View of Restoration Site Showing Forested Wetland, Wet Meadow, Riparian Zone, Restored Stream Channels and Floodplain Bench along Pequest River
